HYUNDAI Technical Service Bulletin

GROUP CAMPAIGN	NUMBER 22-01-027H
DATE MARCH 2022	MODEL(S) ELANTRA N (CN7 N)

SUBJECT: CN7 N MANUAL TRANSMISSION CLUTCH DISC INSPECTION AND REPAIR (SERVICE CAMPAIGN T8B)

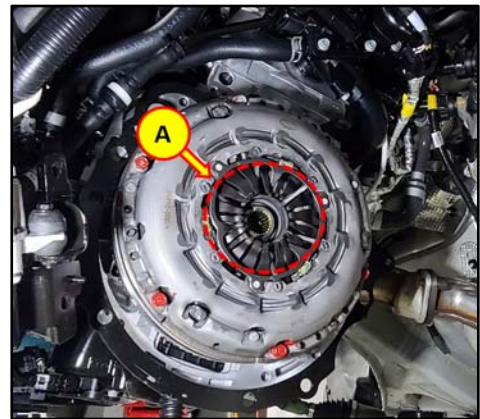
2. Inspect the clutch disc (A) for "T/M SIDE" markings.

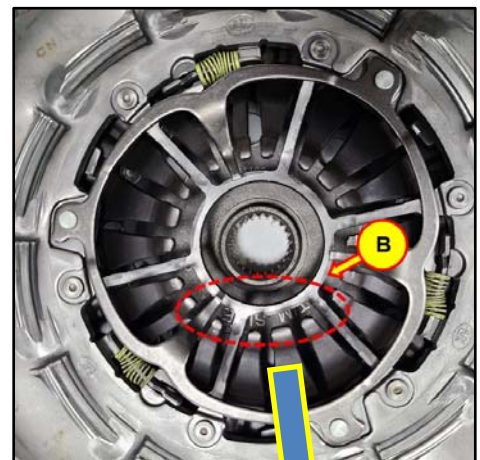
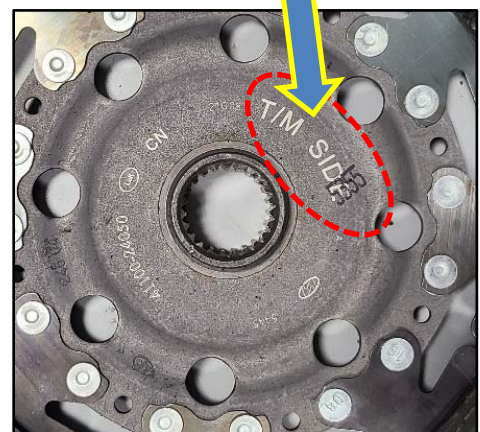
3. If the "T/M SIDE" (B) is visible, the clutch disc is installed correctly and no further repair is needed.

Reinstall transmission in the reverse order of removal.

Perform slave cylinder bleeding to complete the service procedure.

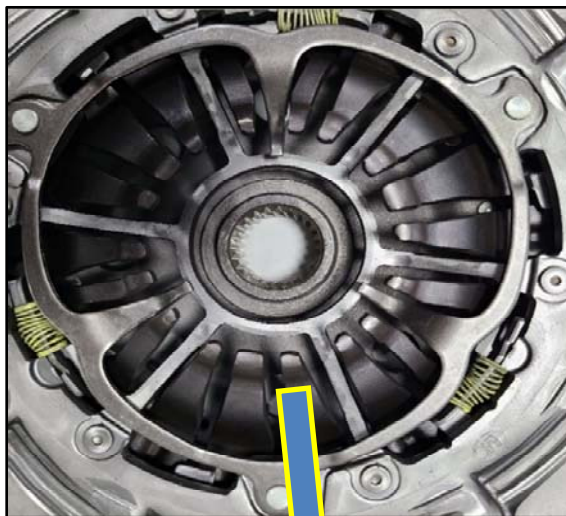
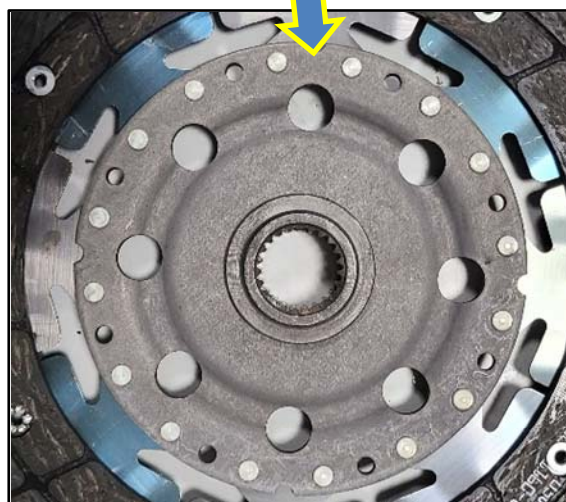
Description: Certain Elantra N (CN7 N) vehicles may have been produced with the clutch disc installed in the reverse direction, potentially causing premature wear due to less clearance between the disc and pressure plate. This bulletin outlines the procedures to inspect the clutch disc, and if necessary, repair the condition.

4. If 'T/M SIDE' marking (C) is not visible, continue with the service procedure below.
