Technical Service Bulletin

GROUP CAMPAIGN	NUMBER 22-01-030H
DATE MARCH 2022	MODEL(S) ELANTRA (AD/ADa)

SUBJECT: TCU UPDATE AND IVT REPLACEMENT
(SERVICE CAMPAIGN 963)

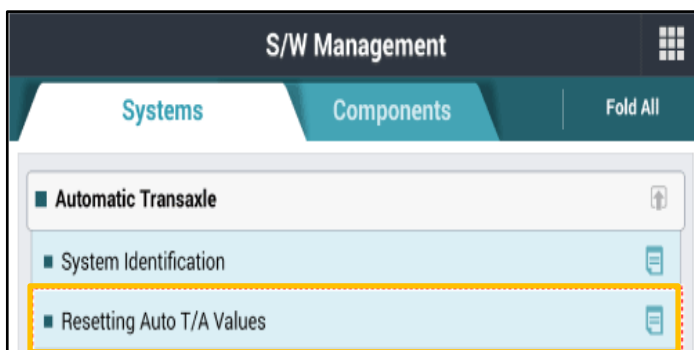
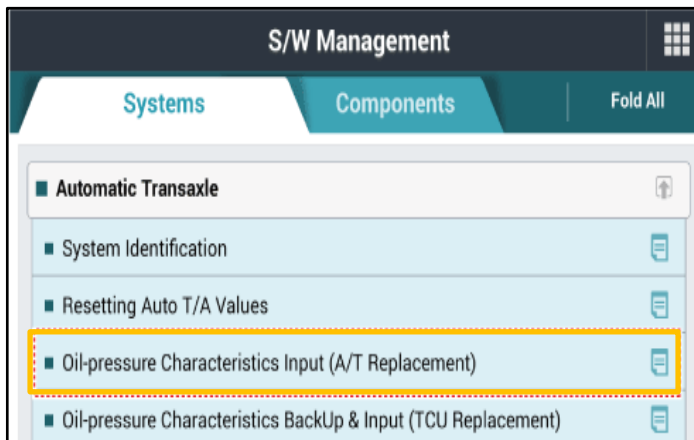
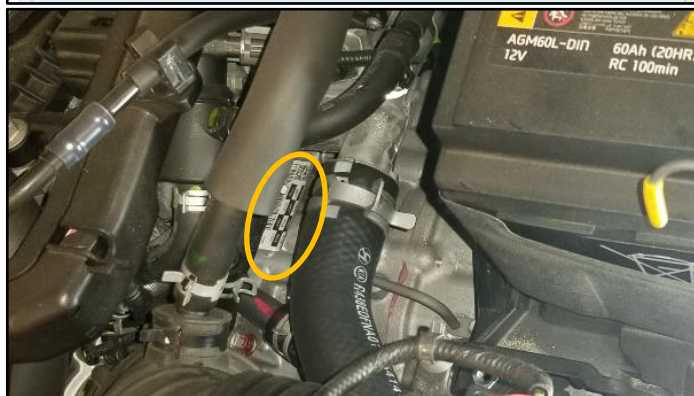
C. IVT, TCU Pressure Learning

1. Perform IVT Resetting Auto T/A Values and Oil-pressure Characteristics Input procedures using the GDS-M.

IVT oil pressure characteristics label is located on the IVT bell housing.

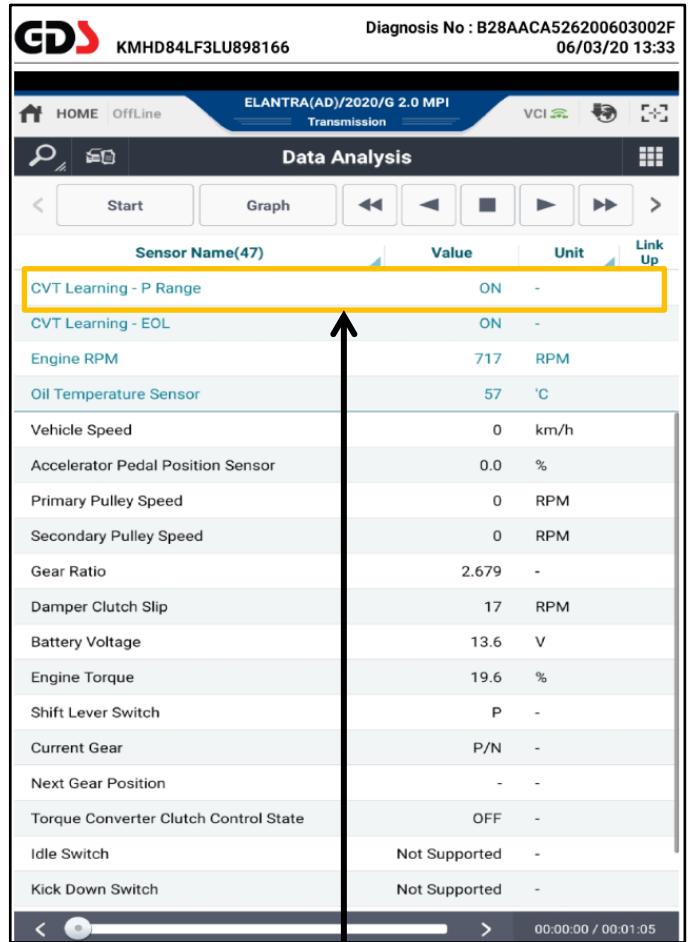
Use the GDS-M to verify the IVT P-Range learning is complete, and check TCU for DTC P1603 (EOL P-Range Pressure Learning Failed).

- If IVT- P Range learning is not complete, and P1603 is present, replace the IVT (Refer to **Section D.**)
- If IVT-P Range is not complete, and P1603 is not present, the learning condition has not been met. Re-perform **Section C** - IVT, TCU Learning.
