<b>HYUNDAI</b> <b>Technical Service Bulletin</b>	GROUP <b>CAMPAIGN</b>	NUMBER <b>22-01-032H</b>
	DATE <b>MARCH 2022</b>	MODEL <b>ELANTRA (CN7) KONA (OS)</b>
<b>SUBJECT:</b>	WATER TEMPERATURE SENSOR LEAK INSPECTION AND REPAIR (SERVICE CAMPAIGN T8F)

**Description:** On certain 2021 Elantra and 2022 Kona vehicles equipped with 2.0L engine, a coolant leak at the Water Temperature Sensor (WTS) may be observed due to machining burrs at the mounting port of the cylinder head, resulting in improper coolant sealing.

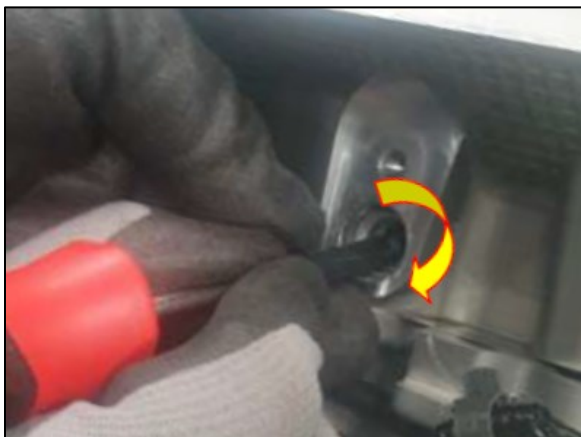
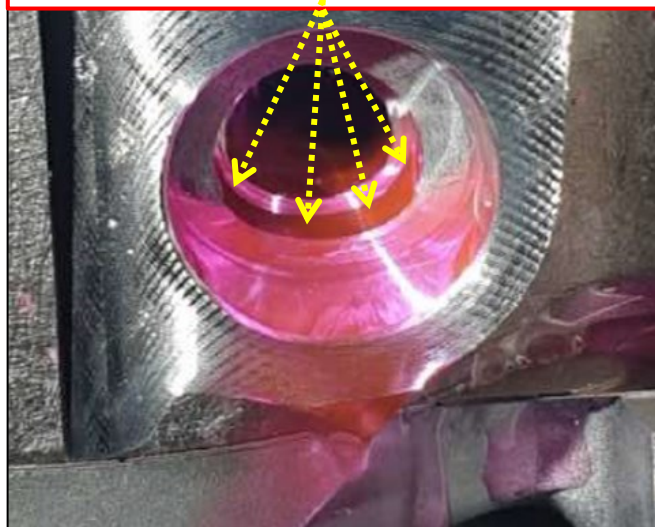
WTS O-ring sealing surface to be sanded

15. Remove the burr while rotating in the circular direction as shown by the arrow for about 8 ~ 9 times while maintaining a perpendicular angle to the WTS mounting hole.

After the burr of the WTS O-ring sealing surface has been sanded away, use shop air to blow away the removed burr chips and sanding debris from the WTS mounting hole and its surrounding areas.
