Service Update

N222359580 Oil Temperature Indicator Inoperative

Release Date: April 2022

Models: 2022 GMC Terrain

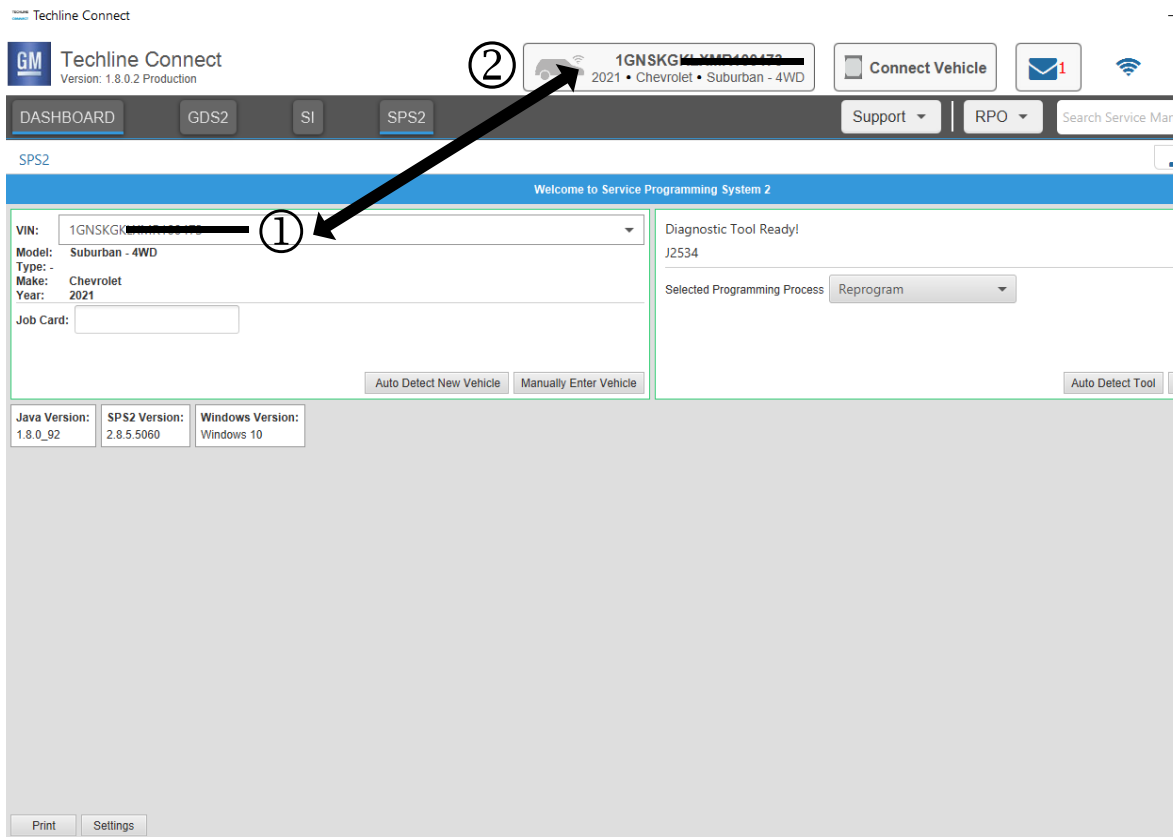
5743643

Caution: Be sure the VIN selected in the drop-down menu (1) is the same as the vehicle connected (2) before beginning programming.
