| BOD | 2017-2022MY Sportage (QL) w/Panoramic Sunroof |
| 306 | April 2022 |

TECHNICAL SERVICE BULLETIN

PANORAMIC SUNROOF INOPERATIVE AND/OR ABNORMAL NOISE WHEN OPERATING

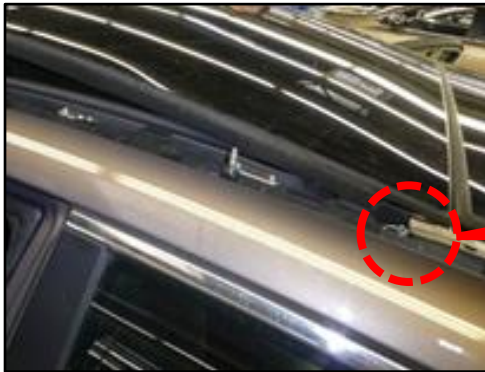
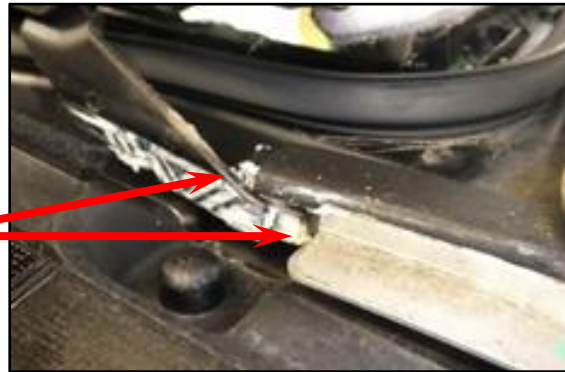
This bulletin provides information to improve the operation of the panoramic sunroof on some 2017-2022MY Sportage (QL) vehicles, produced from December 10, 2015 through December 7, 2021, which may exhibit slow, noisy, or inoperative sunroof operation caused by dust or dirt intrusion into the sunroof track mechanism. Vehicles driven in dusty environments with a high concentration of sand or dirt in the air, may accumulate debris into the sunroof mechanism causing friction. Follow the procedure outlined in this publication to replace the tilt lever shoe assemblies, clean, and lubricate sunroof components to restore normal operation.

Dust and Dirt Inside Panoramic Sunroof Mechanism

1. Inspect the operation of the panoramic sunroof and confirm the customer's concern before conducting this repair. If the concerns are confirmed, inspect for dust and dirt inside the sunroof mechanism, and if verified, continue with this TSB.
2. Remove both roof rack side rails by referring to the "Body (Interior and Exterior) → Body Side Molding → Roof Rack → Repair procedures" chapter in the applicable Shop Manual on KGIS.
