Service Update

N222364700 Steering Gear Aluminum Casting Defects

Release Date: April 2022

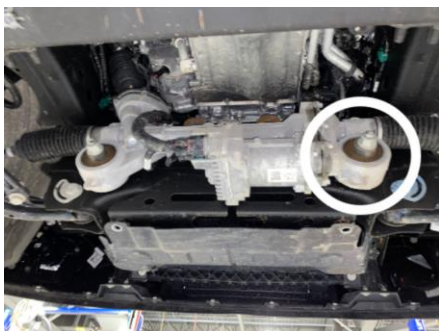
6043738

- Inspect the steering gear in the location shown for evidence of a crack.
 - If the steering gear does NOT show evidence of a crack, no further action is required. Proceed to step 4.

- If the steering gear DOES show evidence of a crack, replace the steering gear. Refer to *Electric Belt Drive Rack and Pinion Steering Gear* in SI.
4. Install the underbody skid shield. Refer to *Underbody Skid Shield Replacement* or *Steering Gear Skid Shield Replacement* in SI depending on your RPO.
 5. Lower the vehicle. Refer to *Lifting and Jacking the Vehicle* in SI.
