PIC6451 Paint Peeling Around the Front Fascia

Brand:	Model:	Model Years:	VIN:		Engine:	Transmissions:
			from	to		
Chevrolet	Corvette Stingray	2020 - 2022	All	All	All	All

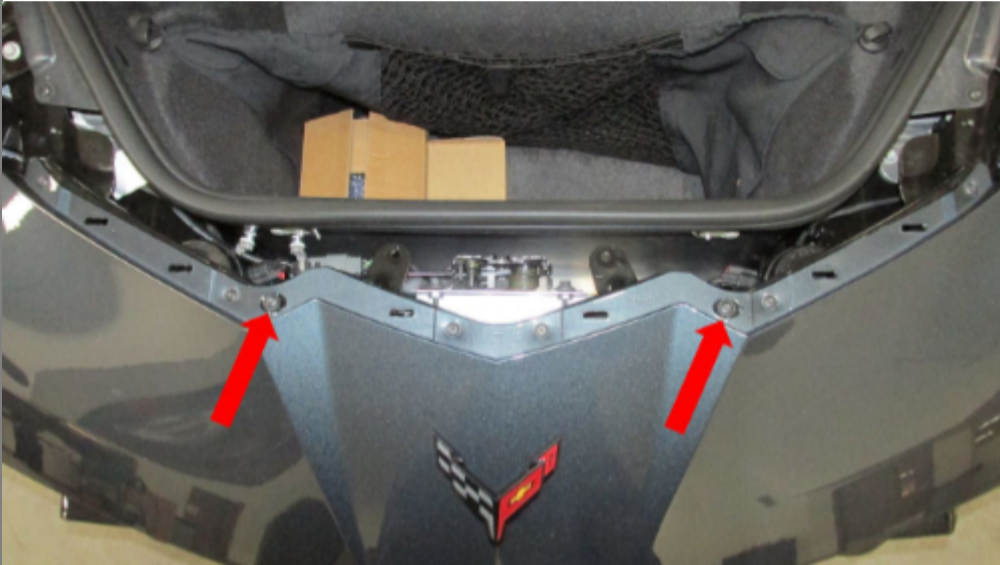
Condition	Some customers may notice that there is a small paint chip on the front fascia, near either the left hand or the right hand headlamp capsules.
-----------	--

Concern	<p>This concern may be caused by several different issues. Engineering is attempting to gain additional information on this concern. If you have a vehicle that has a paint blemish that appears to be caused by the headlamp capsule on one of these vehicles, please follow the steps below:</p> <ol style="list-style-type: none"> 1) Gain access to the front fascia "locators". To do this, no tools are actually needed and it will take about 1 minute of time. This involves removing several front compartment trim panels by hand that are simply held in place by tension clips. 2) First remove the LH and RH Front Compartment Side Sight Shields 3) Next, remove the Front Compartment Rear Access Cover 4) Finally, remove the Front Compartment Front Sight Shield 5) This will allow access to the front fascia "locators", which will require inspection. 6) Technicians will need to look at these locators to see if they appear centered in the slots. This is a 15 mm locator that is placed in a 22 mm slot. This leaves 3.5 mm of open space, on each side of the locator. <p>Before any repairs are actually made, take several pictures of the concern. Please refer to PIC6346A for some general guidelines on how to take clear photos and send them in to the Technical Assistance Center. In addition to taking clear photos of the concern showing the general area in question, take several, clearly focused close-up photos of the chip in the paint as well. Then, please take a couple photographs of the "Front Fascia Locators" on the vehicle in question. These locators can be seen in the two photos below. The first photo is a computer drawing that illustrates these locators. The second photo is where they can be found on an actual car.</p>

7) Lastly, create a TAC case for this concern and attach the photos to the DCM case.

NOTE: When attaching the photos to the TAC case, the LH and RH side locators MUST be labeled.
