Preliminary Information

PIC6275C Intermittent P018B, P0AC4, U18A2, P16E0, Stall, or Reduced Power Message, Cause by a loss of power to the fuel pump drive control module

Brand:	Model:	Model Years:	VIN:		Engine:	Transmissions:
			from	to		
Chevrolet	Volt	2016 - 2019	All	All	L3A	MKV

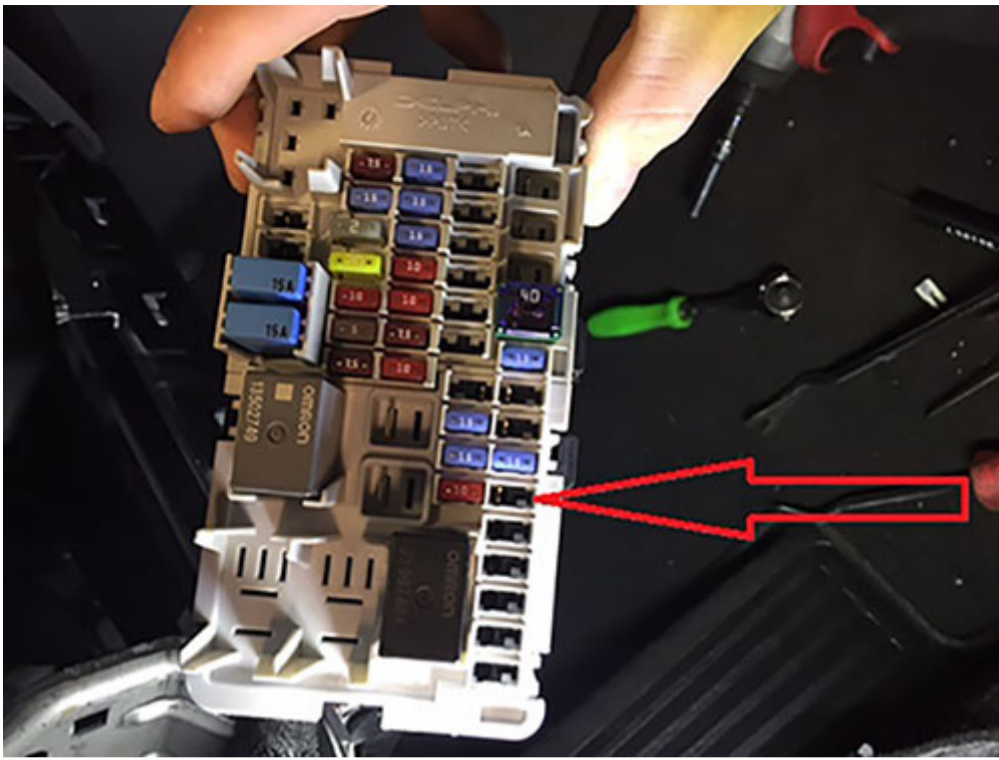
Involved Region or Country	North America
Condition	SES Light, possible stall or Reduced Power message in range extend mode. Possible codes P018B P0AC4 U18A2 P16E0.
Cause	Loose terminal in the IP fuse block

If you have a concern related to the K111 Fuel pump drive control module. Check the X51A Instrument panel fuse panel for a loose terminal to fuse F9DA. This is could be causing an interment power issue on ckt 1540, Please drag test Terminal 51 at the fuse block using Diagnostic Test Probe J-35616-35 (VT)

If a loose terminal is found, Replace it with the right terminated lead listed in SI (Service Information).
