## PIT5899A Diagnostic Tip for Back-up Camera, Back-up lamps and/or Vanity lamps inoperative

Brand:	Model:	Model Years:	VIN:		Engine:	Transmissions:
			from	to		
Buick	Encore	2014 - 2022	All	All	All	All
Chevrolet	Trax	2014 - 2022	All	All	All	All

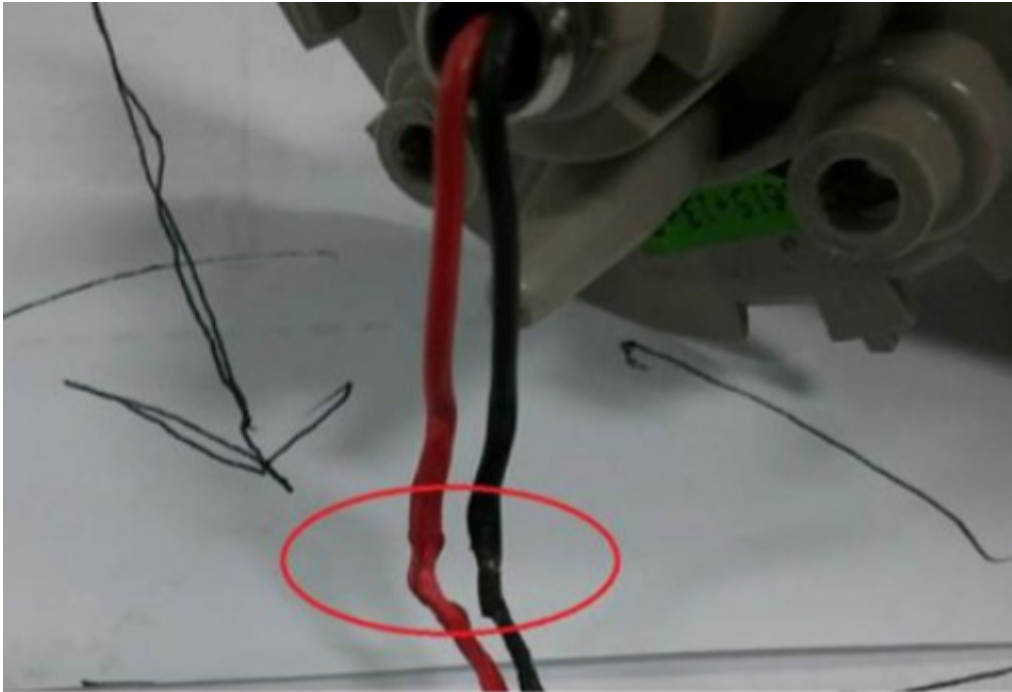
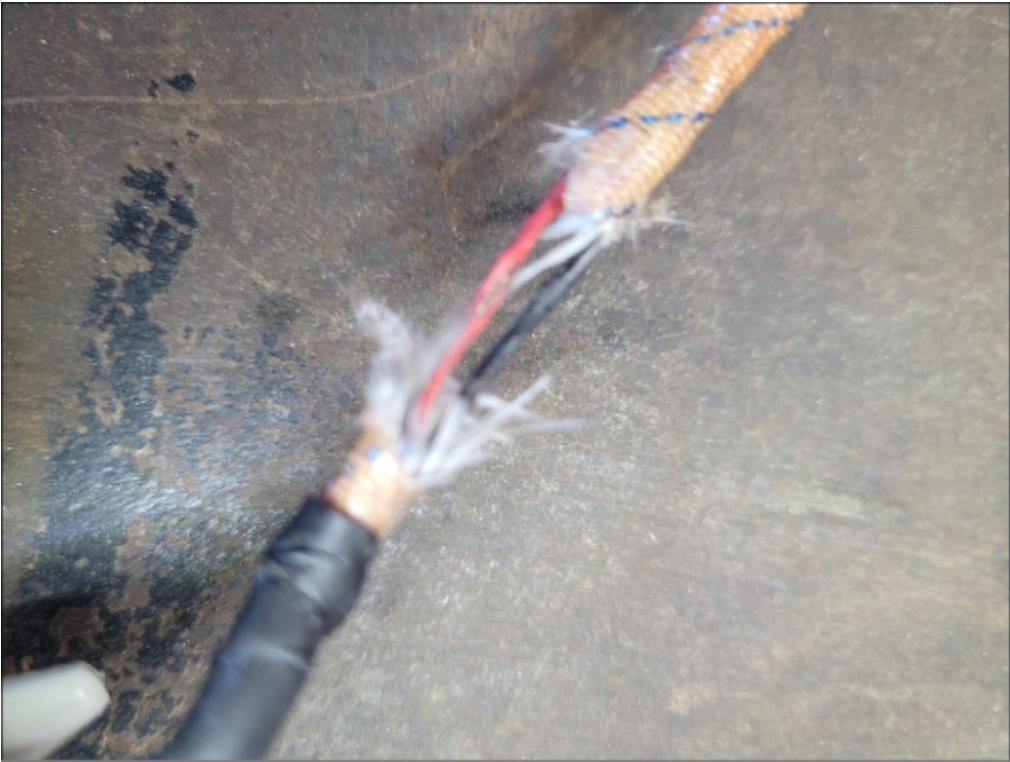
Involved Region or Country	North America
Additional Options (RPO)	UVC
Condition	Some customers may notice that back-up camera, back-up lamps and/or vanity lamps are inoperative.  Technicians may find any of the following DTC's B127B, B133B or B2545
Cause	This may be caused by an open fuse F6DA, which could be caused by the headliner harness or vanity lamp harness being pinched at the either LH or RH sunshade mount.

Dealers should remove both sunshade assemblies and inspect the headliner or sunshade harnesses for being pinched. If harness is pinched, dealers should perform a wire to wire repair as outline in Service Information.
