Published date: 03/23/2022

## **Preliminary Information**

## PIP5845 Engine Coolant Reservoir Overfilled With Discolored Coolant Possible Engine Overheat Transmission Shake Shudder Vibration Shift Performance Or Slipping

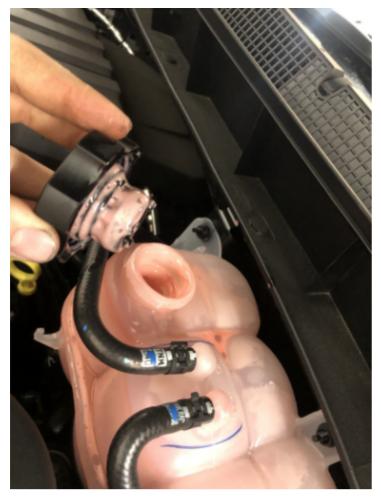
| Involved Region or Country | North America |
|---|--|
| | Some customers may comment of the following conditions:<br>Engine coolant reservoir is discolored with a strawberry milkshake appearance and |
| | may be overfilled to the point where coolant is being expelled from the overflow. |
| | See photo below (coolant is not bright orange and translucent). |

| Condition | See photo below (coolant is not bright orange and translucent).<br>In addition to above, engine may experience an overheat condition<br>In addition, possible degraded transmission performance including any of the<br>following:<br>Shudder, vibration, shake, shift performance and slipping.<br>The transmission fluid level may be low when checked. |
| Cause | The Automatic Transmission Fluid Cooling Exchanger may have an internal leak allowing transmission fluid and engine coolant to intermix contributing to the above conditions. |

Confirm the presence of coolant in the transmission fluid using Service Bulletin # 08-07-30-035 (Information on Water Ethylene Glycol in Transmission) in SI

Using 08-07-30-035 as a guide repair or replace the transmission assembly following SI Replace the Automatic Transmission Fluid Cooling Exchanger

Thoroughly Flush the Engine Coolant System to remove the contaminated engine coolant following SI. Refill the engine coolant system following SI
