Diagnosis of Wireless CarPlay Connectivity USA Complaints Audio/Visual/Telematics Outline-Audio/Visual/Telematics Applicable 21MM Lexus Models

2022	NX250	2022	NX350H	
2022	NX350	2022	NX450H+	
2022	LX600			,

Tech Tip L-TT-0312-22

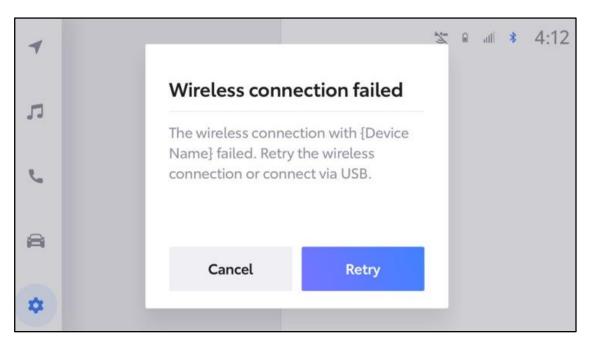
- Difficulty to connect or start using the wireless CarPlay
- Intermittent wireless connection failed error message when driving or first turning on the vehicle

These conditions can be caused by changes on the customer's phone. Make sure to inquire with the customer if the connectivity concerns occurred before or after receiving an operating system update on their phone or if they have restored their phone data/settings recently.

Below is a sample image of a wireless CarPlay error pop-up message:

Use the troubleshooting flow, figure references, and data collection template below prior to submitting a field report or opening a TAS case.
