Subject		Market	
O2 and/or A/F Sensor DTC's Related to Exhaust Leaks		USA	
Service Category	Section		
Engine/Hybrid System	Intake/Exhaust		
Applicability			
Multiple models equipped w/2GR-FKS/FXS

2017-2022	Highlander	2017-2019	Highlander HV
2016-2022	Tacoma	2017-2020	Sienna
2018-2022	Camry	2019-2022	Avalon

The purpose of this Tech Tip is to provide diagnostic tips to prevent misdiagnosis of the following DTC's and prevent repeat repairs.

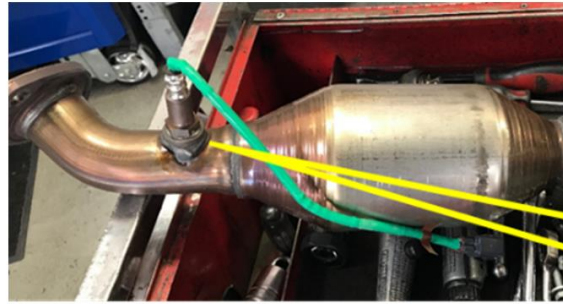
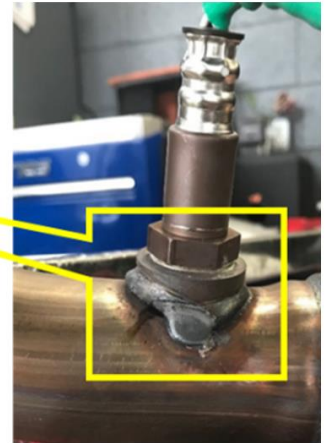
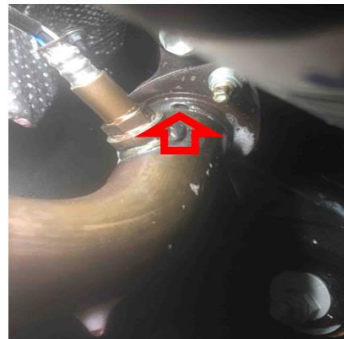
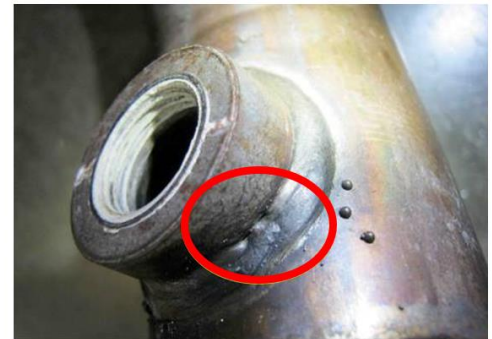
Pin hole leaks in welds can be especially difficult to locate.

If a weld does not have a consistent bead, chances of a pinhole are high.

Pinholes in the sensor mounting boss, or upstream will introduce unmetered oxygen into the exhaust and give a false (typically lean) reading.

- Check welds for inconsistent beads
 - If this condition occurs, remove sensor and replace pipe.
 - Sensor can be reused in this case

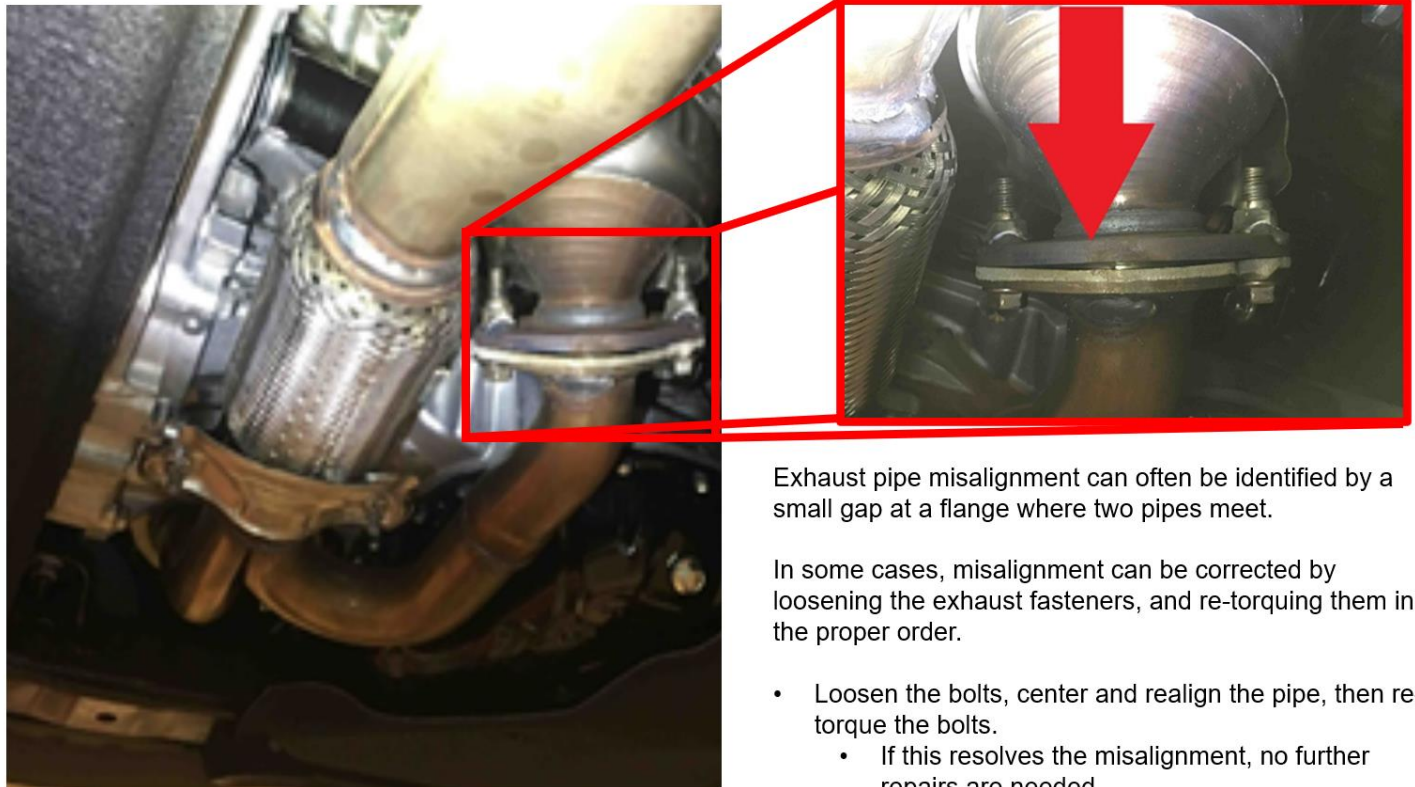
Exhaust pipe misalignment can often be identified by a small gap at a flange where two pipes meet.

In some cases, misalignment can be corrected by loosening the exhaust fasteners, and re-torquing them in the proper order.

- Loosen the bolts, center and realign the pipe, then re-torque the bolts.
 - If this resolves the misalignment, no further repairs are needed.
 - If the gap remains, pipe replacement will likely be necessary.

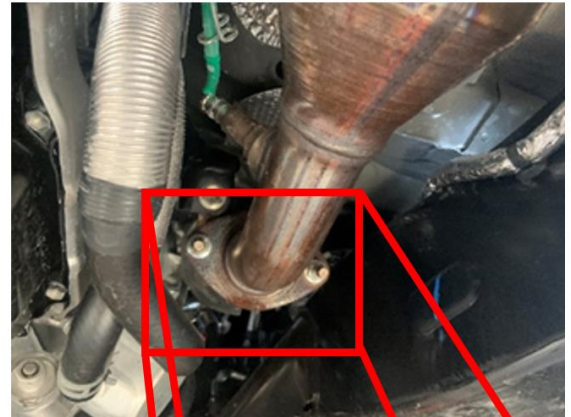
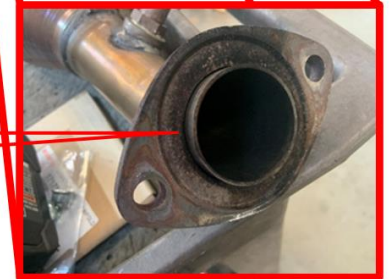
Exhaust pipe to pipe flange connection typically employ a gasket to seal the joint. If the gasket is missing or damaged, a leak will result.

In most cases a new gasket can be installed in the location of the leak.

- Check for presence of gasket
- If missing, install new gasket

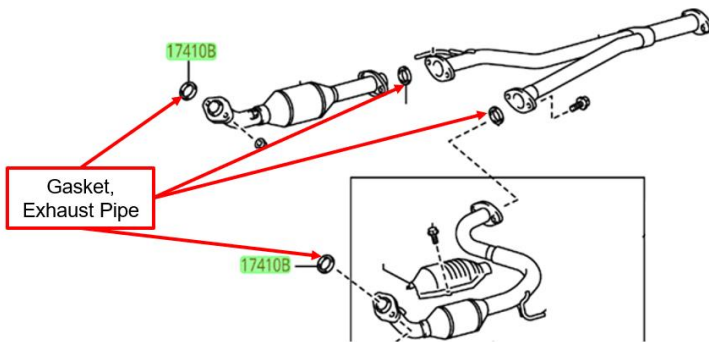
Gasket is missing
