| <b>Re: Recall Campaign Launch Notification</b><br><b>Model 907 (Sprinter)</b><br><b>Model Years 2021</b><br><b>Replace Tire and Loading Information Label</b> | DATE: March, 2022 |

Campaign No. 2022030008 March, 2022

SUBJECT: **Model 907 Sprinter, Model Year 2021**  
**Replace Tire and Loading Information Label**

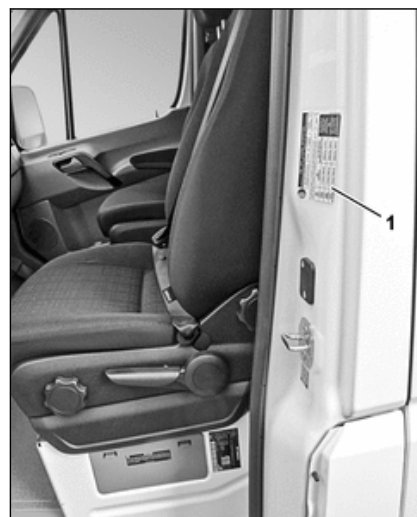
D40.10-1127-02

Mercedes-Benz AG ("MBAG"), the manufacturer of Mercedes-Benz & Freightliner Sprinter vans, has determined that on certain 907 (VS30) platform Sprinter vehicles, the tire and loading information label on the B-pillar could contain erroneous values that overstate the Gross Vehicle Weight Rating. Due to erroneous values for the maximum permissible combined vehicle weight on the tire and loading information label on the B-pillar, overloading of the vehicle could exceed the permissible total weight. As a consequence, over time, this could cause excessive tire wear and in a worst case scenario, could lead to tire failure, which could increase the risk of a crash. MBUSA/DVUSA is conducting a voluntary recall. An authorized Mercedes-Benz/Freightliner Sprinter dealer will check the tire and loading information label and replace it with a corrected label. Additionally, a visual inspection of the tires for excessive wear will be conducted. If necessary, tires with excess wear will be replaced on the affected axles.

1 Tire pressure table information label

| 2<br> <b>WS</b> | Replace tire pressure table information label (1).<br>000 588 00 84 00 Heat gun | <p> <b>Installation:</b><br/>Bonding surface must be absolutely free of dust and grease. Otherwise, a sufficient degree of adhesion cannot be assured.</p> <p> <b>Removal:</b><br/>Do not heat the B-pillar under the tire pressure table information label (1) too much. Otherwise the paint will be damaged.</p> <p> <b>Removal:</b><br/>To do so, remove the old tire pressure table information label (1) with a suitable tool and remove adhesive residue with a suitable cleaning agent.</p> | WS54.00-P-0049B |
| 3 | Attach protective foil at tire pressure table information label (1). | | |

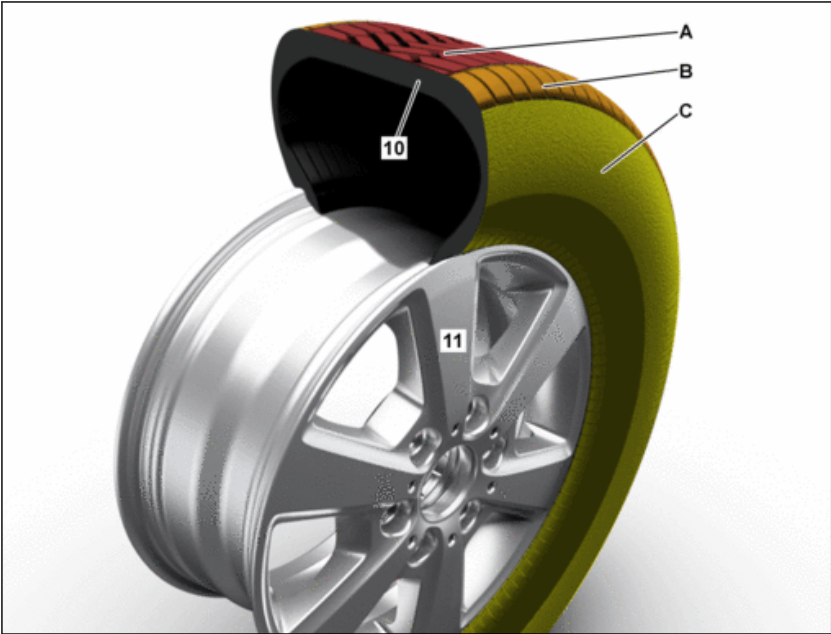
D40.10-A008-76

**Schematic diagram of tire structure**

| 5 | Check wear at tire shoulders (B). | <p> If the air pressure of the tires (10) is incorrectly adjusted, the wear at the tire shoulders (B) may be significantly increased in particular.<br/>If tire shoulders (B) do not exhibit any increased wear,<br/>↓<br/>Continue with operation step 7 and end measure.<br/>If tire shoulders (B) exhibit increased wear,<br/>↓<br/>continue with operation step 5.</p> | |

| 6<br> AR | Replace tires (10) of affected axle. | <br>Always replace tires (10) on an axle-by-axle basis.<br><br>Tire specifications for the order can be found in the previously installed tires (10). | AR40.10-D-1030TS |
