**RECREATIONAL VEHICLE SERVICE CAMPAIGN**

**SERVICE ADVISORY 22-426**

## SERVICE ADVISORY # 22-426

### Coleman Inverter Wiring

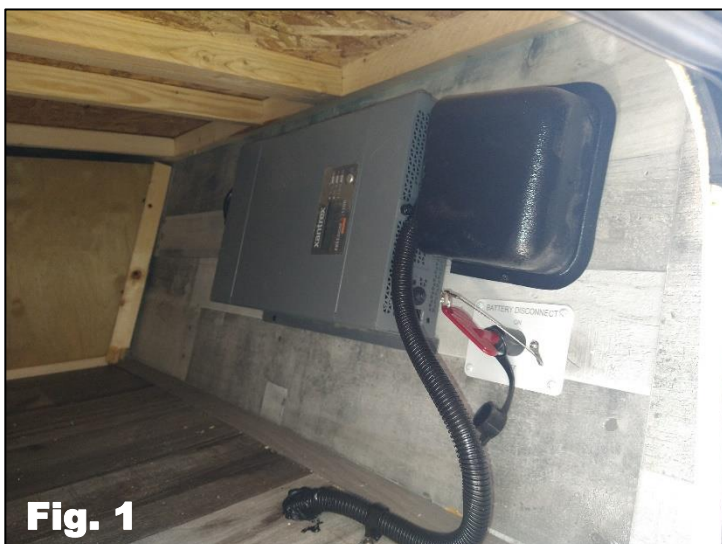
**Fig. 1**

Determine if the unit was built with a 120 VAC refrigerator. Inspect the front pass-through compartment and determine if an inverter is installed, see Figure 1. If one is not present, the unit was manufactured with a 12 VDC refrigerator, proceed to warranty reimbursement. If an inverter is present, proceed to the repair instructions.

Remove the top panel from the bunk. Locate the wire bundle where it enters the unit through the floor, see Figure 3. Using the shortest/fastest route through the underbelly, install a 12-3 SJOOW cord through the access hole and route it to the front pass-through compartment of the unit. Fasten the 12/3 SJOOW to cross members whenever possible using zip ties (shop supplied part). Drill a hole through the floor in the front pass-through compartment to allow the 12-3 SJOOW cord to enter, see Figure 1.
