Service Action

Code: 94P7

Subject Rear Level Sensor Stud

Release Date April 14, 2022

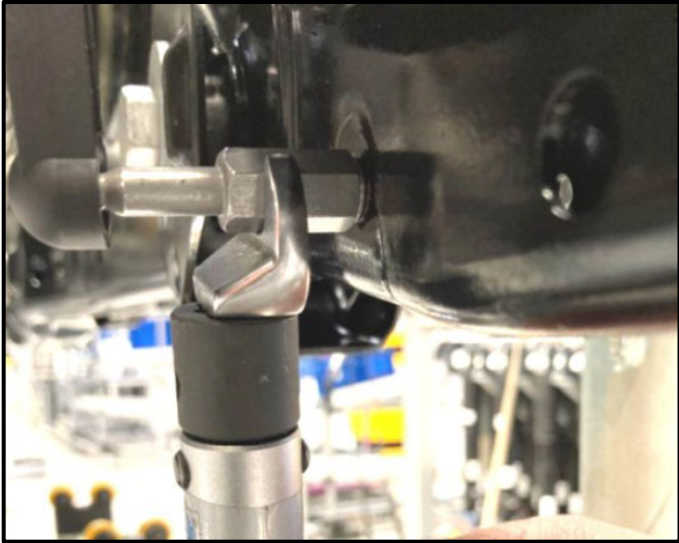
Repair Overview

Problem Description On certain vehicles, the rear level sensor stud may not have been torqued to the correct value.

- Re-torque rear level sensor stud.
