GROUP
Engine

NUMBER
PS720

DATE
April 2022

INJECTOR HARNESS ROUTING FOR PI1802Y/Z AND PI1803Y/Z ENGINE REPLACEMENTS

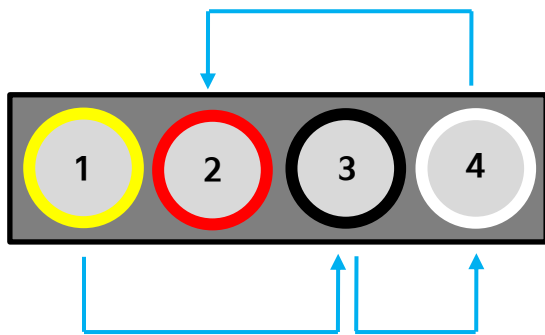
- Cylinder #1 connector harness has Yellow tape.
- Cylinder #2 connector harness has Red tape.
- Cylinder #3 connector harness has Black tape.
- Cylinder #4 connector harness has White tape.

Correct Cylinder → Injector Harness Tape
Connector Coloring Identification.

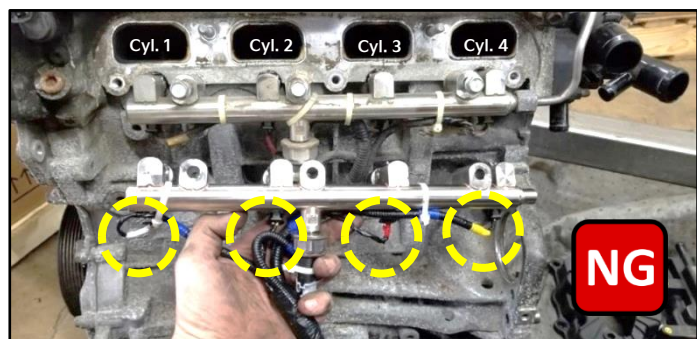
Sample of an incorrectly installed injector harness below. The order is backwards.
