Service Bulletin

Bulletin No.: 22-NA-076

Subject: L5D Engine Control Module Update

Brand:	Model:	Model Year:		VIN:		Engine:	Transmission:
		from	to	from	to		
Chevrolet	Silverado 4500HD, 5500HD, 6500HD	2021	2021			L5D

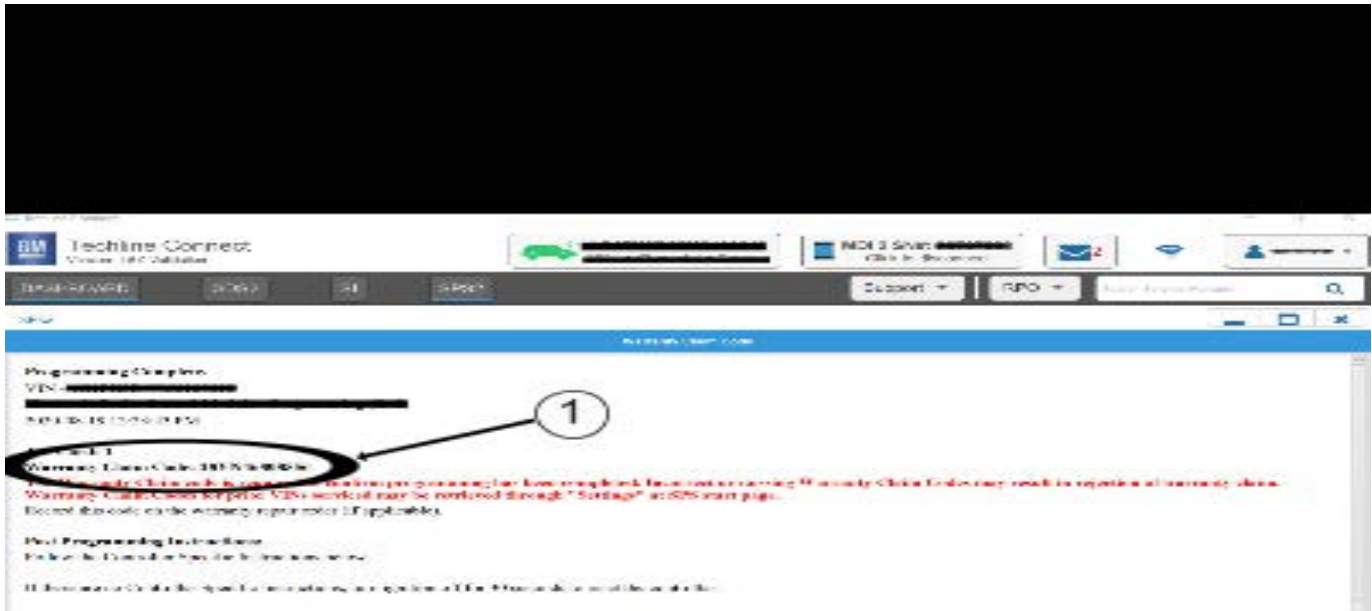
5644478

Important: To avoid warranty transaction rejections, you **MUST** record the warranty claim code provided on the Warranty Claim Code (WCC) screen shown above on the job card. Refer to callout 1 above for the location of the WCC on the screen.

2. Record Warranty Claim Code on job card for warranty transaction submission.
