## TECHNICAL SERVICE BULLETIN

### 3.0L EcoBoost - Buzz/Vibration/Rattle Noise Underneath Vehicle Near The Left Rear Door - Built On 25-Jan-2022 And Through 10-Mar-2022

22-2135

19 April 2022

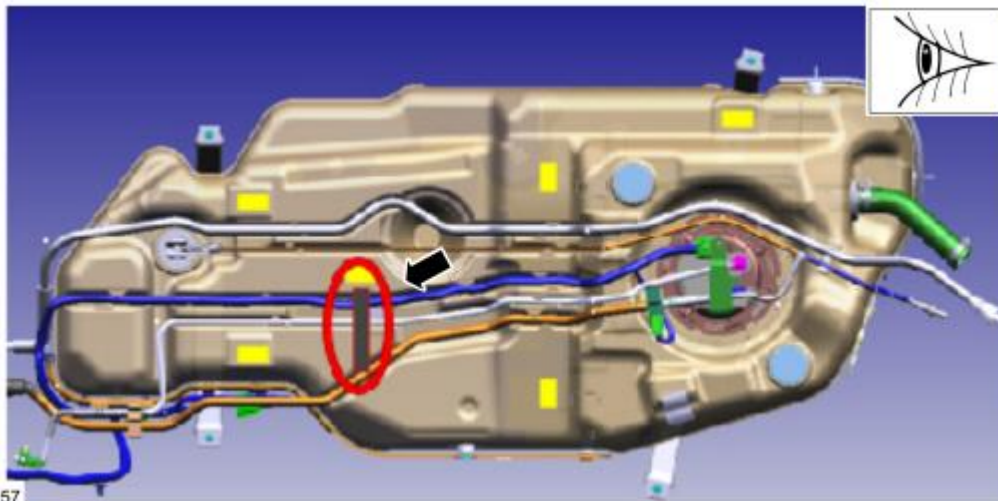
Figure 1

**Issue:** Some 2022 Explorer/Aviator vehicles equipped with a 3.0L EcoBoost engine and built on 25-Jan-2022 and through 10-Mar-2022 may exhibit a buzz/vibration/rattle noise at engine idle or low revolutions per minute (RPM) underneath the vehicle near the left rear door. This may be due to the pressurized fuel delivery line contacting the body or the fuel tank creating a buzz/vibration/rattle noise. To correct the condition, follow the Service Procedure to install foam patches.

1. Remove the fuel tank. Refer to Workshop Manual (WSM), Section 310-01.
2. Clean the top of the fuel tank in the area outlined in Figures 1-2 with soapy water and/or isopropyl alcohol as needed.

3. Stack 3 Rotunda hard foam patches on top of each other.
4. Install the stack of 3 Rotunda hard foam patches in the circled area. (Figures 1-2)
5. Make sure that the fuel line convolute shown in Figure 3 is seated in the retaining clip. (Figure 3-4)
