Subject: REVISION: N212354170-02 – Emission Recall
DPF Regeneration Temperature
Population Expansion to Include US VINs

Models: 2020 Chevrolet Silverado 2500HD/3500HD
2020 GMC Sierra 2500HD/3500HD
Equipped with the 6.6L Diesel Engine (RPO L5P)

Product Emission Recall

N212354170 DPF Regeneration Temperature

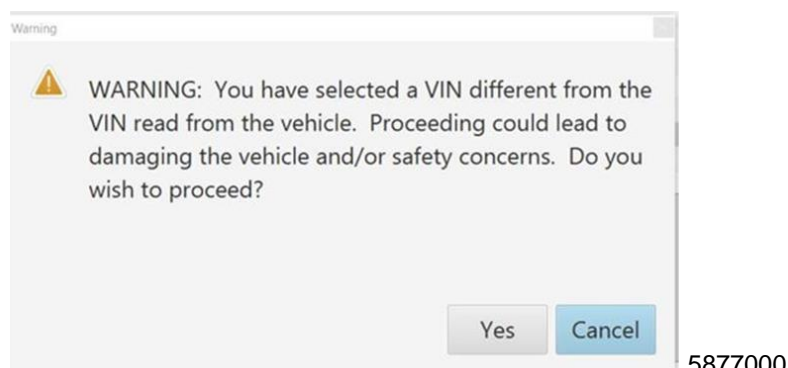
5877000

Important: If the vehicle VIN DOES NOT match, the message below will be shown.

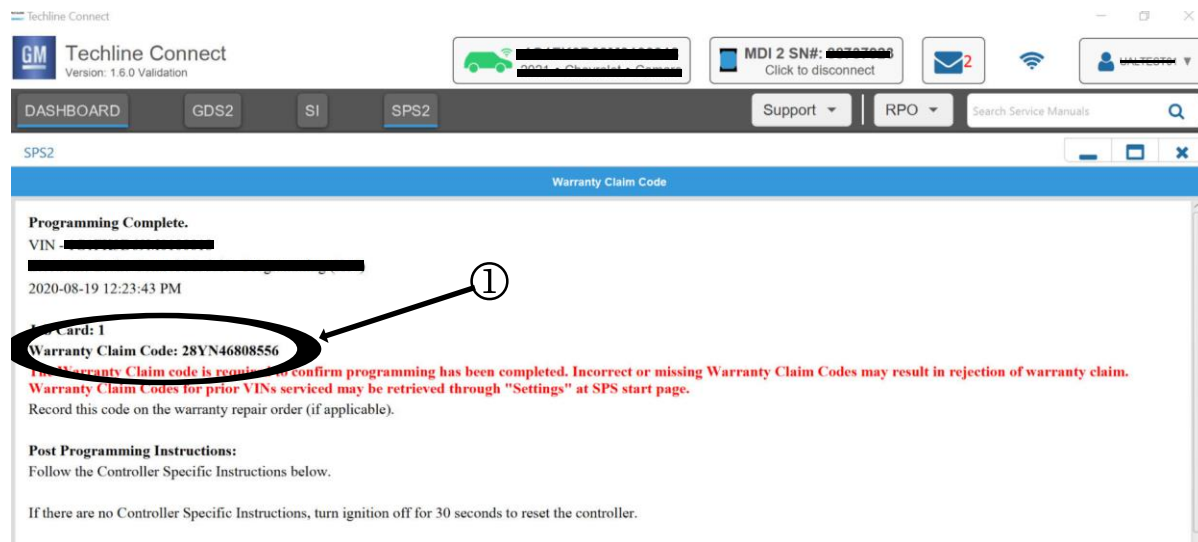
5644478

Note: The screenshot above is an example of module programming and may not be indicative of the specific module that is being programmed. Module selection and VIN information have been blacked out.

Important: To avoid warranty transaction rejections, you **MUST** record the warranty claim code provided on the Warranty Claim Code (WCC) screen shown above on the job card. Refer to callout 1 above for the location of the WCC on the screen.

- Record SPS Warranty Claim Code on job card for warranty transaction submission.
- CALIFORNIA VEHICLES ONLY: Complete a "Proof of Correction" certificate and provide to the vehicle owner upon recall completion.
