Service Update

N222364701 Steering Gear Aluminum Casting Defects

Release Date: April 2022

Revision: 01

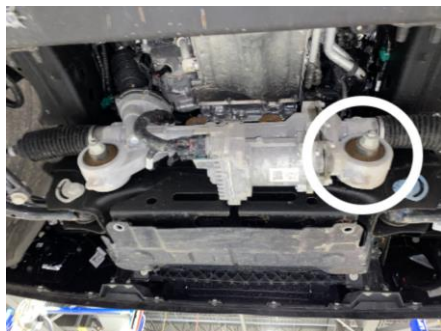
6043738

3. Inspect the steering gear in the location shown (top left circle) for the cavity code.
 - If the cavity code is not K13 no further action is required, proceed to step 6.
 - If the cavity code is K13, proceed to step 4.
4. Inspect the steering gear in the location shown (bottom right circle) for the cast date code.
 - If the cast date code is not 051, 22 or 058, 22 no further action is required, proceed to step 6.
 - If the cast date code is 051, 22 or 058, 22 proceed to step 5.
5. Replace the steering gear. Refer to *Electric Belt Drive Rack and Pinion Steering Gear Replacement* in SI.
6. Install the underbody skid shield. Refer to *Underbody Skid Shield Replacement* or *Steering Gear Skid Shield Replacement* in SI depending on your RPO.
7. Lower the vehicle. Refer to *Lifting and Jacking the Vehicle* in SI.
