# Technical Service Bulletin

## 68 Noises from the front center console

68 22 35 2063737/2 April 16, 2022. Supersedes Technical Service Bulletin Group 68 number 21-34 dated June 21, 2021 for reasons listed below.

Model(s)	Year	VIN Range	Vehicle-Specific Equipment
A6, and A7	2019 – 2023	All	Not Applicable
S6, A6 allroad, and S7	2020 – 2023		
A7 e quattro	2021 – 2022		
RS 6 Avant, S7, and RS 7	2021 – 2023

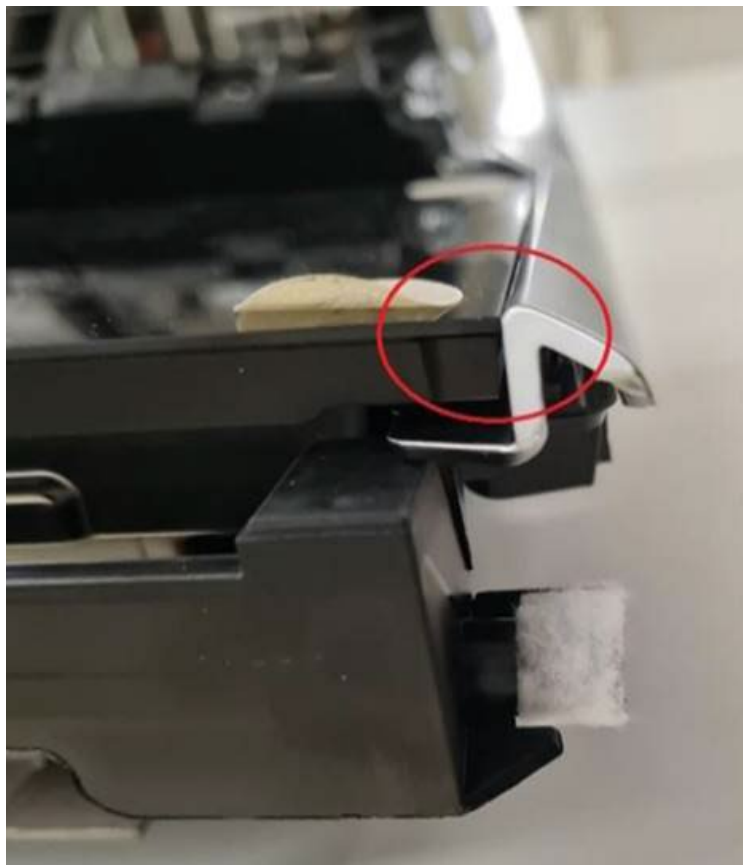
There is hard contact between the lower MMI display and the front center console insert/trim.

Due to the tight assembly tolerances, the lower MMI display may make contact with the center console insert/trim (Figure 1).

*Figure 1. Hard contact between lower MMI display and center console insert/trim.*

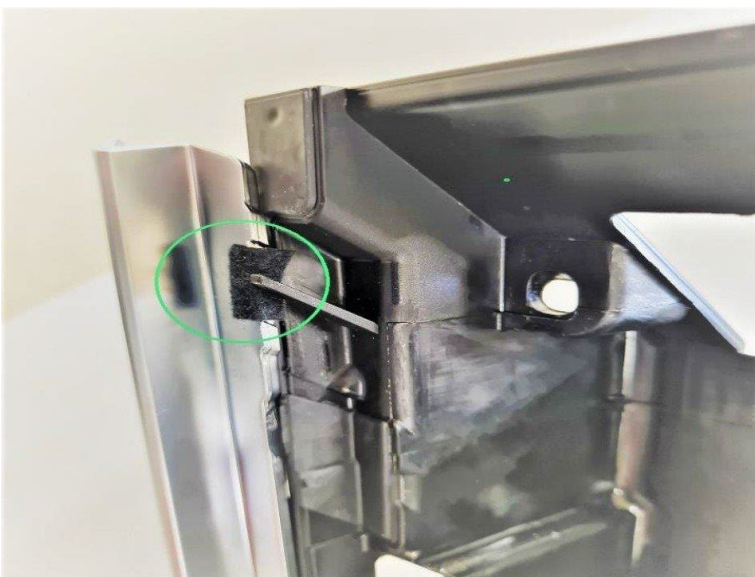
*Figure 2. Felt tape applied between the rib of the display mount and the trim frame.*

4. Only on the side of the contact, apply a strip of felt tape (approx. 3/4 x 3/8 inch) between the rib of the display mount and the trim frame to increase the gap to the display on that side only (Figure 2).
