72 Squeaking noise from the front seat height adjustment

72 22 43 2059448/4 April 16, 2022. Supersedes Technical Service Bulletin Group 72 number 21-36 dated September 17, 2021, for reasons listed below.

Model(s)	Year	VIN Range	Vehicle-Specific Equipment	
Q5, and SQ5	2017 – 2023			
Q5 e quattro, Q5 Sportback, and SQ5 Sportback	2021 – 2022	All	Not Applicable

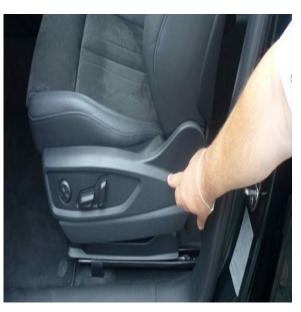
• The source of the squeaking noise can be tracked to the front seat outer hinge area. The noise originates from behind the seat frame trim panel.

Figure 1. Noise originates from behind the seat frame trim panel near the hinge.

Depending on the seat position, under certain conditions, squeaking noises from the front seat height adjustment can occur. Specifically, in the lower seat adjustment positions, the toothed segment of the seat height adjustment can interfere with the support bracket resulting in squeaking noises.

- 1. Remove the affected seat from the vehicle according to the Elsa Repair Manual.
- 2. Attach the seat to the seat repair fixture VAS6136 mounted to the engine and transmission holder VAS6095A according to the Elsa repair manual.

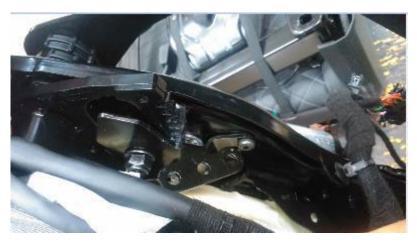
Figure 2. Toothed segment of the seat height adjustment.

Remove the seat frame trim panel and tilt the seat forward to gain access to the seat height adjustment toothed segment.

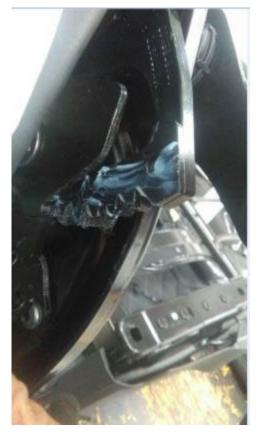
Figure 3. Grease applied to the seat height adjustment toothed segment.

Apply grease spray part number G 052 778 A2 on the toothed segment as shown in Figure 3 (lubricate teeth and lateral surfaces).

- 5. Reinstall the seat frame trim panel and install the seat in the car according to Elsa Repair Manual.
- 6. Adjust the seat up and down three times covering the full range of vertical movement to equally distribute the grease on the toothed segment.
