Technical Service Bulletin

87 Noise from the air conditioning compressor when the AC is active

87 22 26 2063467/3 April 20, 2022. Supersedes Technical Service Bulletin Group 87 number 22-20 dated March 21, 2022 for reasons listed below.

Model(s)	Year	VIN Range	Vehicle-Specific Equipment
e-tron quattro	2019 – 2022	All	Not Applicable
e-tron Sportback quattro	2020 – 2022

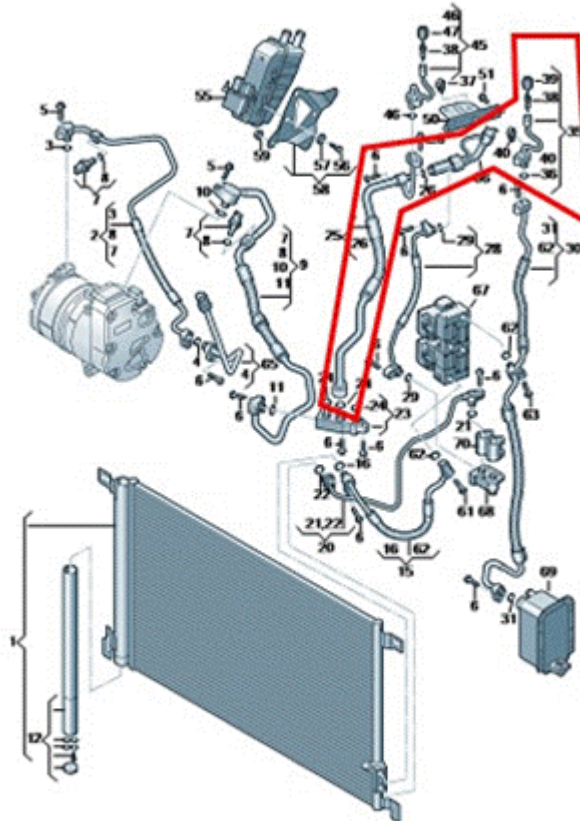
The source of this noise may be due to direct contact between adjacent refrigerant lines (Figure 1) or between a refrigerant line and the Bowden cable clip for the front hood release in the front motor compartment (Figure 2). When the air conditioning compressor is operating the noise created by the vibration is transferred from this point of contact and into the cabin.

Figure 1. The refrigerant lines possibly make contact.

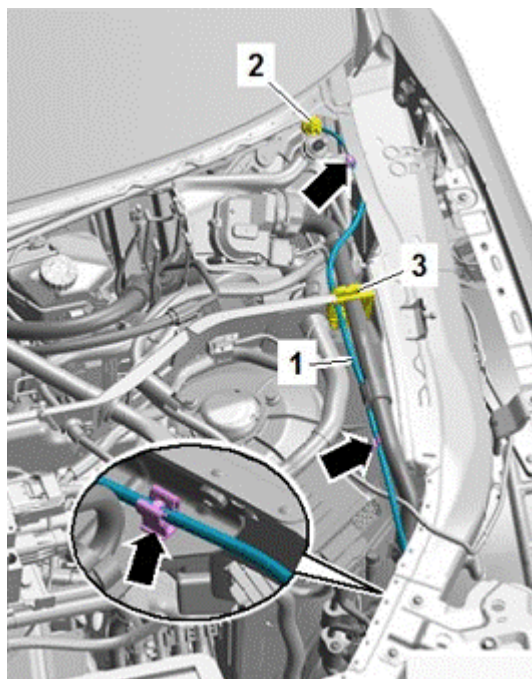
Figure 2. Location of the Bowden cable clip for the front hood release.

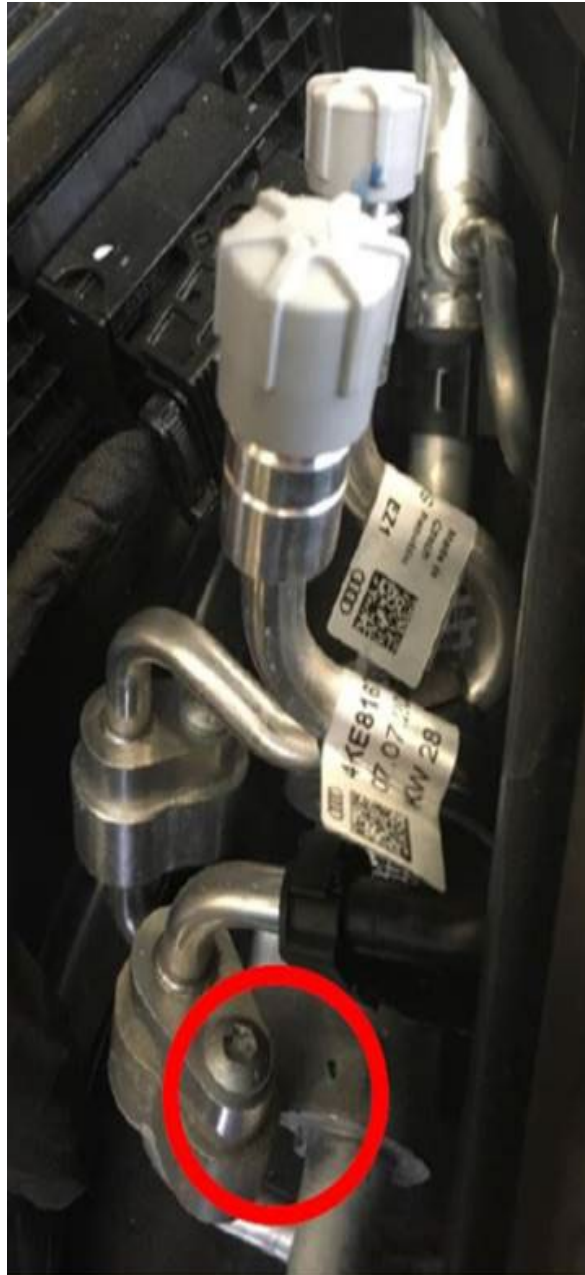
1. Figure 3 shows refrigerant lines close enough to make contact and elicit vibration transfer and noise.

Figure 3. The refrigerant lines are making contact.

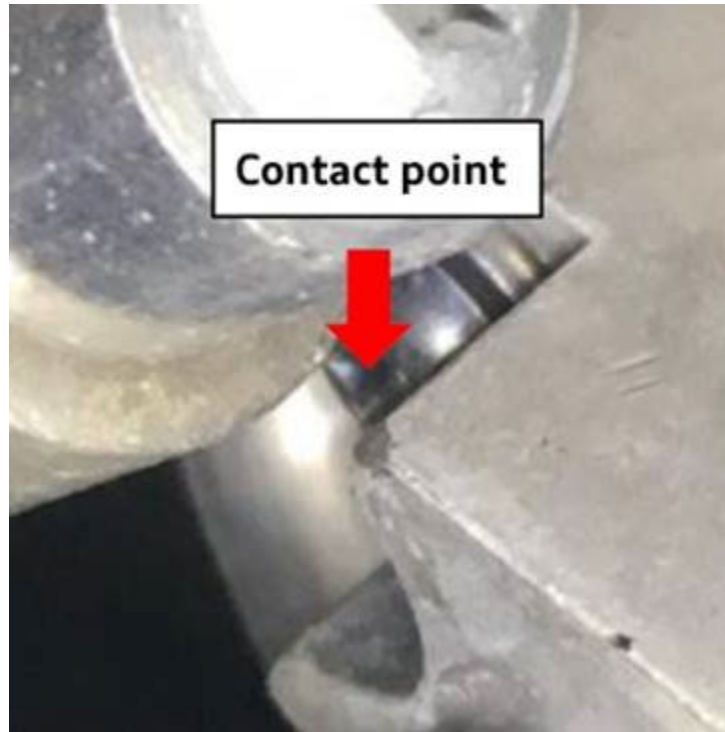
2. Figure 4 shows a close-up view of the point of contact.

Figure 4. Point of contact.

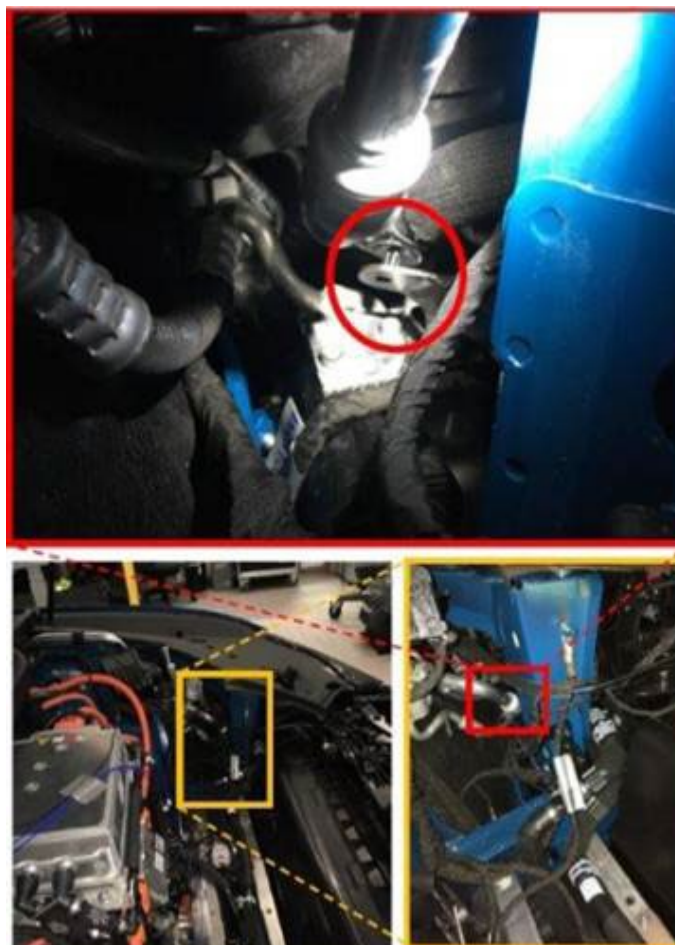
Figure 5. The area in the motor bay where contacting lines are located.

3. These refrigerant lines must be separated and, if necessary, retained in a separated position using a hose holder, clip, or tie-wrap (Figure 5).

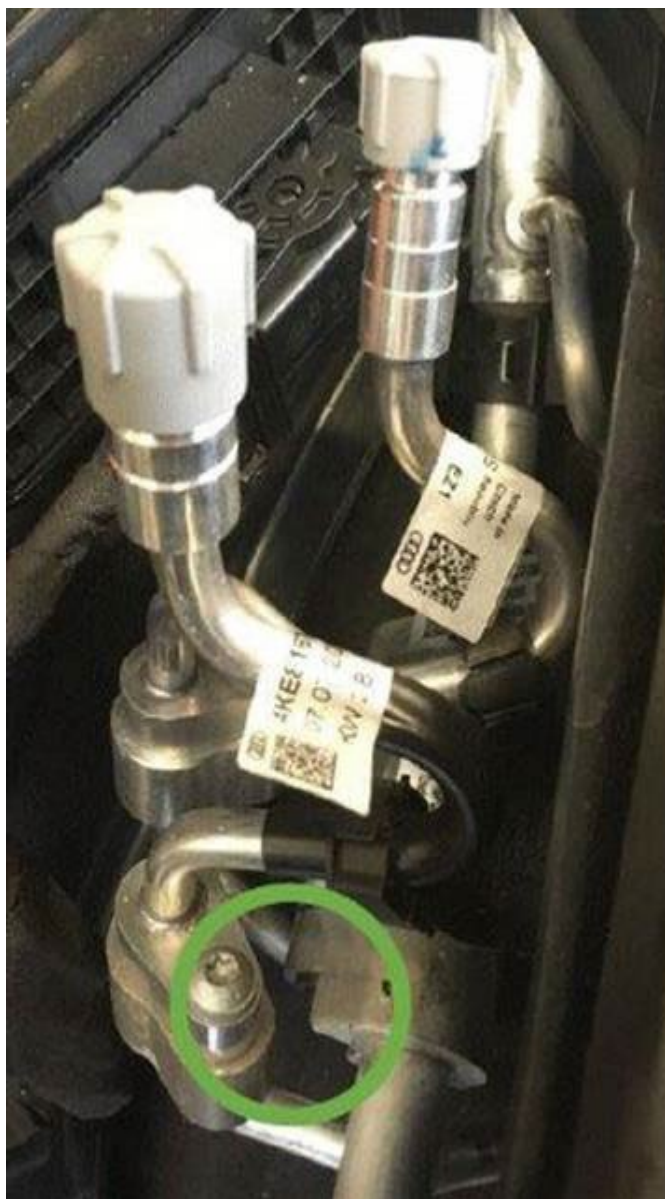
4. Figure 6 shows properly separated refrigerant lines.

Figure 6. Refrigerant lines retained in a separated position.

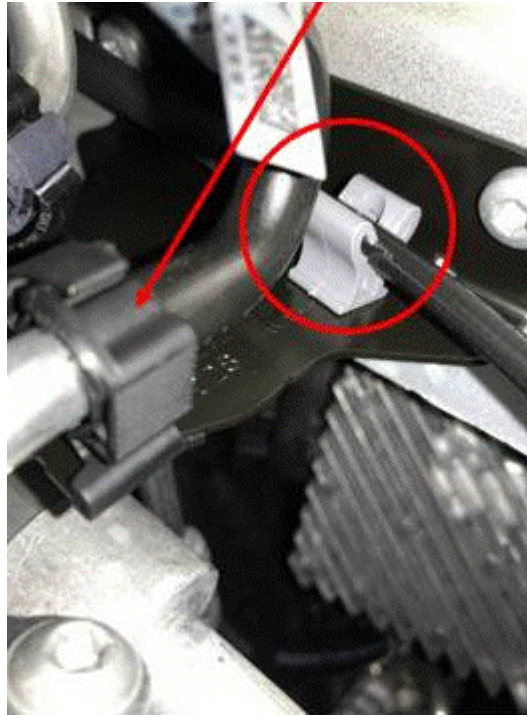
Figure 7. Point of contact between refrigerant line and Bowden cable clip.

5. An additional point of contact may be found between the refrigerant line containing the service port and the clip that retains the Bowden cable for the front hood release. If contact is found here these components must be separated and secured in a separated position. The retaining clip for the refrigerant line allows the line to slide within it. This is to be considered when securing the line away from the clip for the Bowden cable.

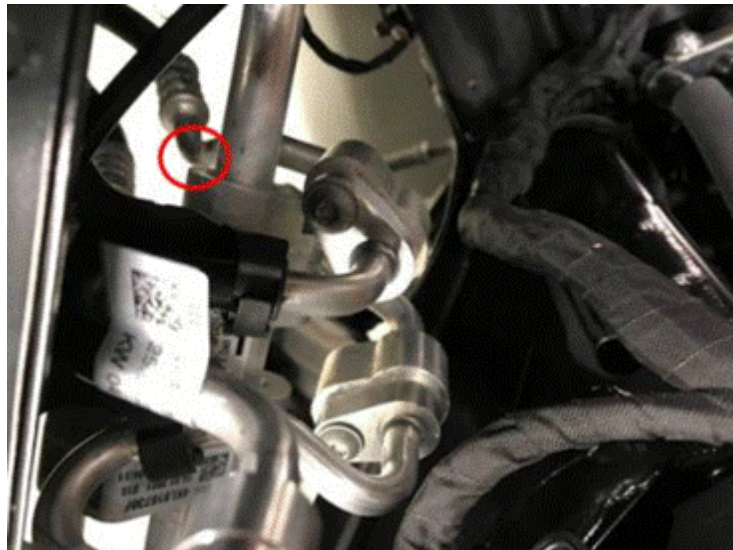
Figure 8. Point of contact between coaxial refrigerant line and the refrigerant line containing the service port.

6. Figure 8 shows an additional point of contact possible at the coaxial refrigerant line where it crosses the refrigerant line containing the service port. Again, separate and secure these lines in a separated position.
