40 Clicking noise from wheel bearing

40 22 38 2024318/12 April 14, 2022. Supersedes Technical Service Bulletin Group 40 number 22-37 dated March 29, 2022 for reasons listed below.

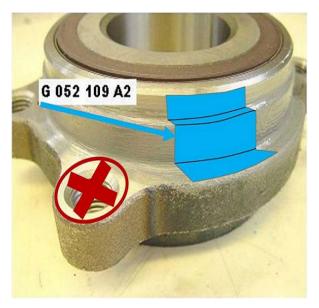
Microscopic movements between the wheel bearing and the wheel bearing housing may cause the noise (front left and/or the front right bearing can be affected).

Figure 1. Area to apply the paste.

2. Using a brush, apply a thin coat of paste part number G 052109A2, using about .21 ounces or 6 grams (roughly 1/20) from the tube on the wheel bearing housing as shown (Figure 1). Make sure not to apply any paste on the threads.
