SS 725-WST 2022 Power Steering Cap Contact with Hood Strap

49X & 47X vehicles equipped with 4qt power steering reservoir

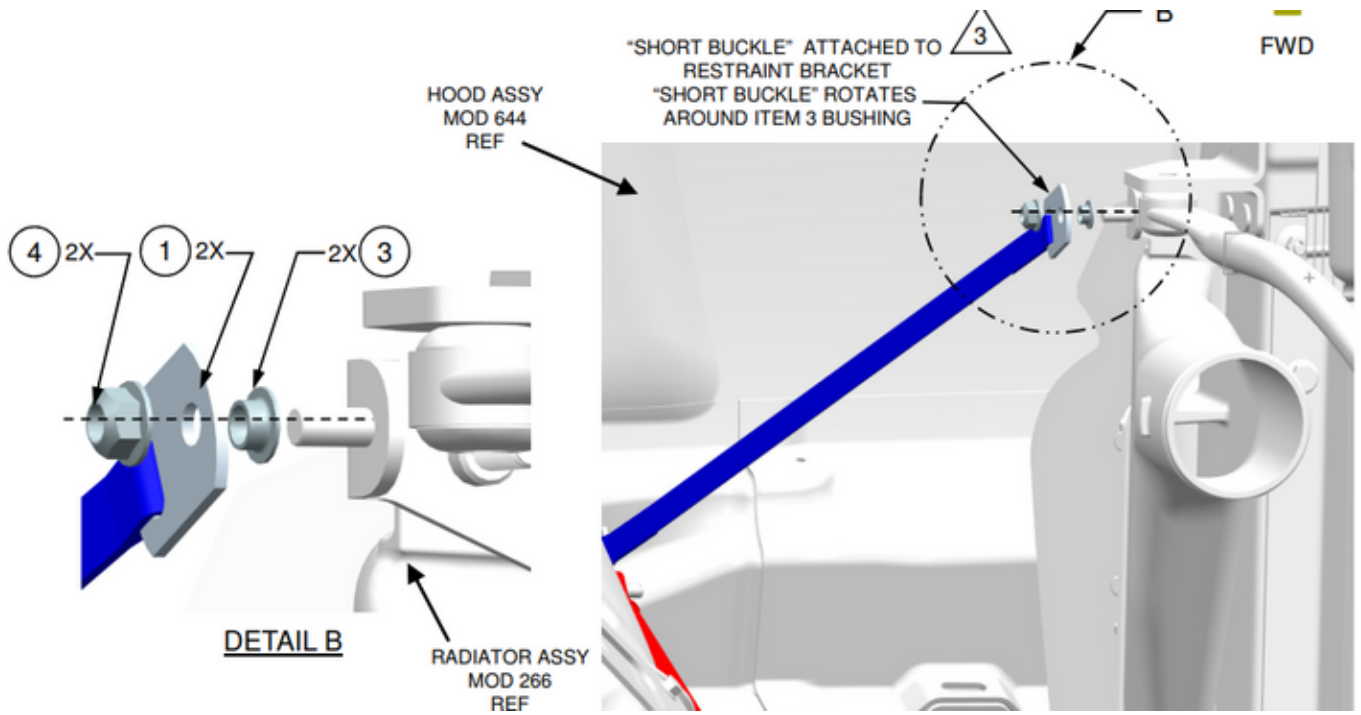
Under certain conditions the drivers side hood restraint strap, which is attached to the radiator and hood, may become lodged behind the power steering cap. When opening the hood, the hood restraint strap may pull on the power steering cap resulting in the cap coming off of the reservoir.

Removal of compression ring bushing from the radiator side of the hood restraint strap installation and torque mounting nuts with restraint strap buckle facing forward per information below:

1. Open hood
2. Remove compression ring bushing (item 3 below)
3. Reinstall strap to radiator stud, leave nut loose
4. Allow hood to rest on restraint straps with hood in full open position and assure the buckle is facing forward
5. Torque nut to 24 ft/lbs
