Technical Service Bulletin

48 Squeaking noises from rubber boot of the intermediate steering shaft

48 22 31 2055733/3 April 28, 2022. Supersedes Technical Service Bulletin Group 48 number 21-96 dated March 16, 2021, for reasons listed below.

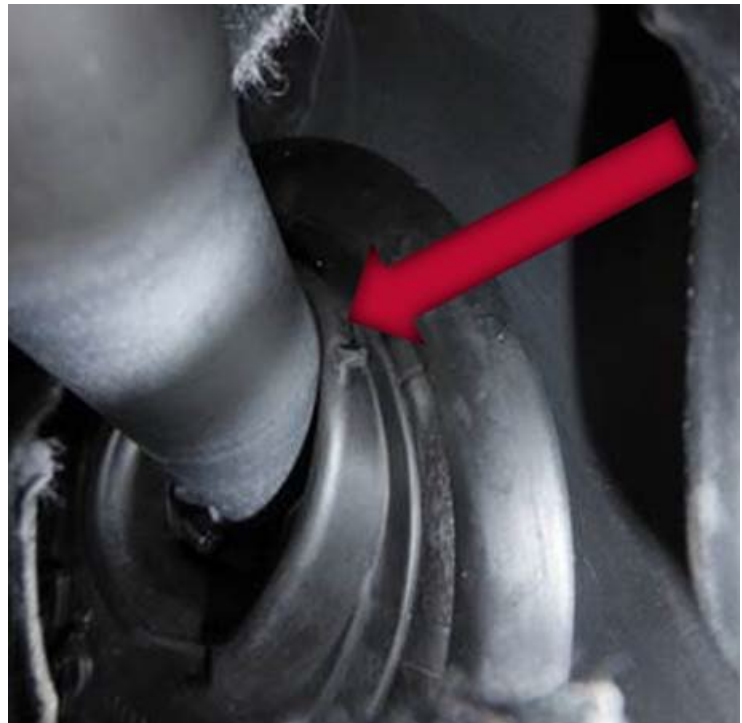
- The noise comes from the sealing sleeve/steering column opening on the bulkhead.
- The steering column adjustment is set in the lower range.
- The steering shaft rests on the cone of the sealing sleeve (Figure 1).

Figure 1. Steering shaft rests on the sealing sleeve (also known as sealing lip).

Incorrect positioning of the sealing sleeve (lip) in the bulkhead in connection with unfavorable tolerances of the components.

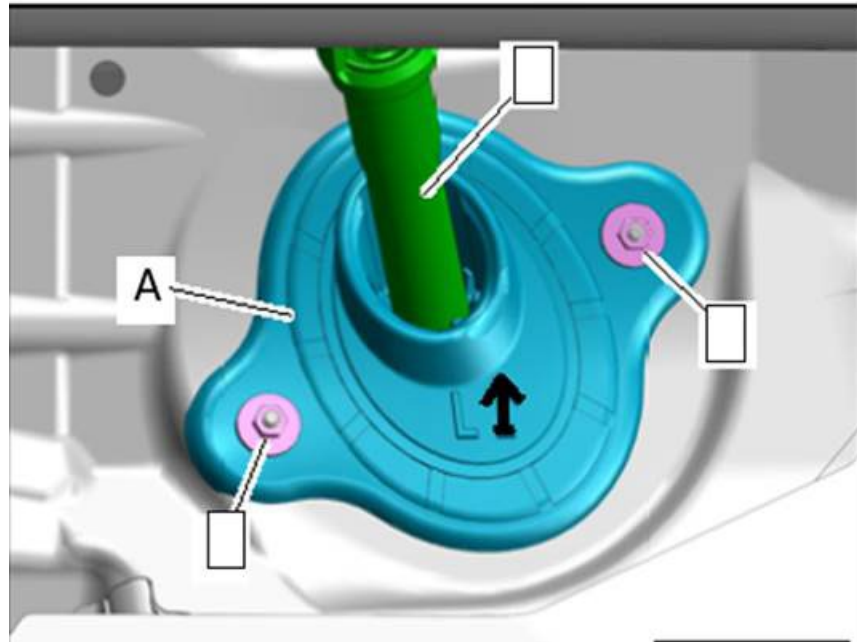
Figure 2. Sealing sleeve (also known as sealing lip).

Loosen the rubber sealing sleeve (A) and push it upwards as far as possible and retighten (Figure 2).

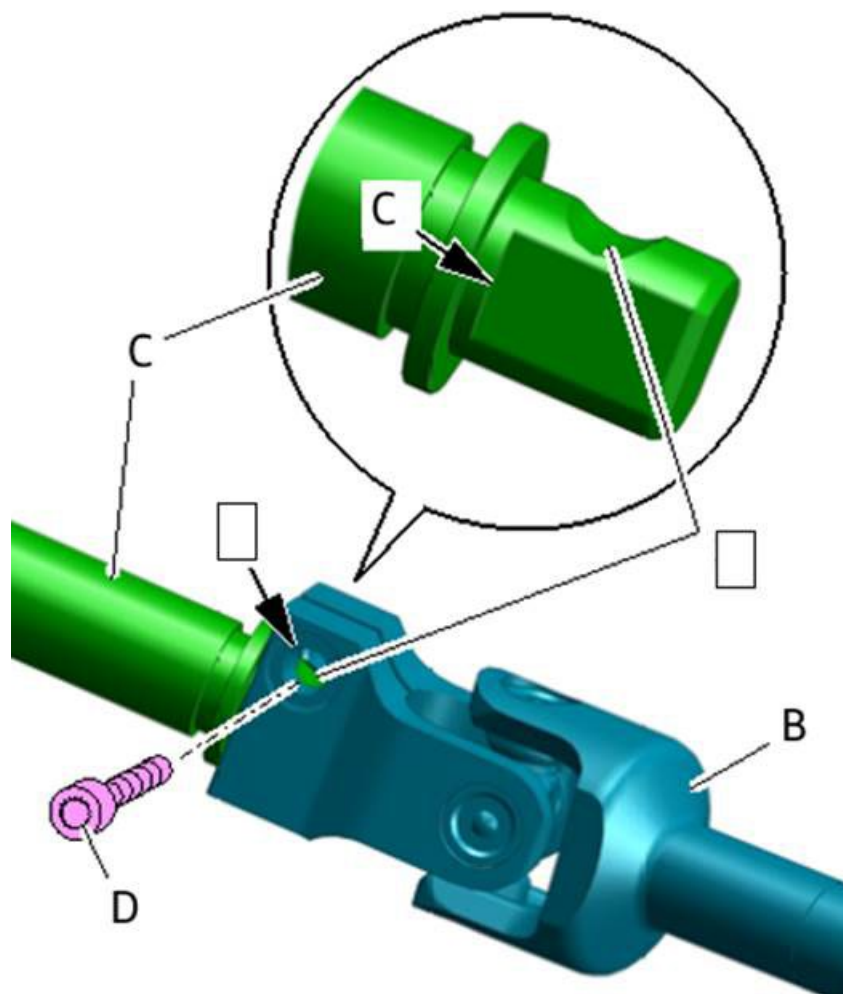
Figure 3. Steering column shaft and intermediate shaft connection.

Reinstall the steering intermediate shaft (B) to the steering column (C) and tighten with new bolts (D) (Figure 3).
