Service Bulletin

Bulletin No.: 22-NA-081

Subject: Paint Peeling or Chipping on Front Fascia at Headlamp or Fender Seam

Brand:	Model:	Model Year:		VIN:		Engine:	Transmission:
		from	to	from	to		
Chevrolet	Corvette	2020	2022	—	—	All	All

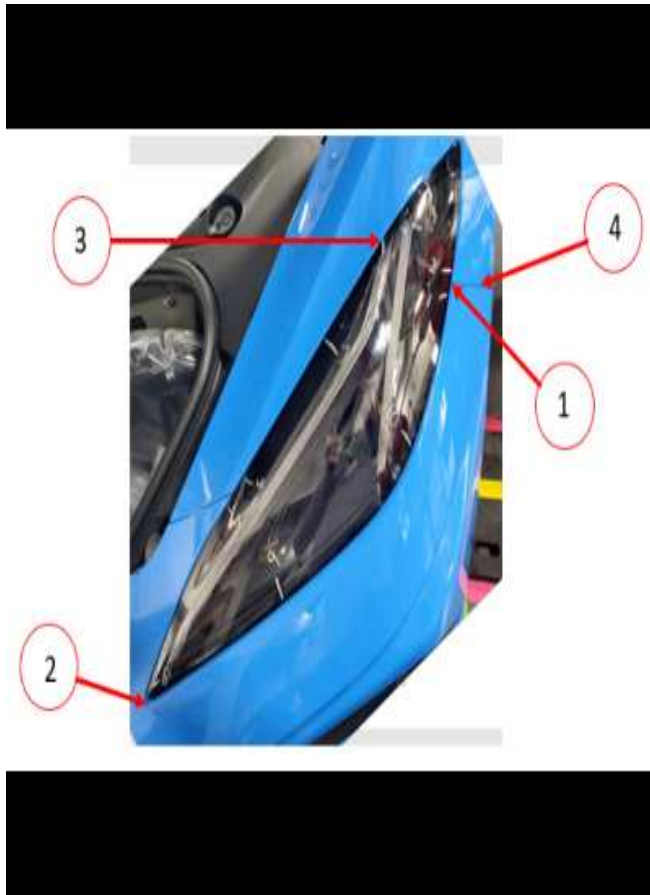
6041596

Involved Region or Country	North America, Europe, Middle East, Japan, Australia/New Zealand
Condition	Some customers may comment on seeing the paint chipping or peeling on the front fascia, or the fender to fascia body seam.
Cause	The cause of the condition may be that the headlamp is positioned too tight to the body panel. The vehicle may also have too tight of a fit between the front fascia and fender.
Correction	Verify the condition and repair following the steps in the Service Procedure below.

There are four potential high contact areas where the paint may chip or peel:

1. Fender/fascia under headlamp (see Service Bulletin # 20-NA-124: Small Front Fascia Paint Chip Below Headlamp).
2. Front corner of headlamp to the fascia.
3. Head lamp tight to fender.
4. Front fascia to fender.
