#### 70 Noises from top of front door trim panel

70 22 74 2066883/1 April 26, 2022.

Model(s)	Year	VIN Range	Vehicle-Specific Equipment	
A5, A5 Cabriolet, A5 Sportback, S5, S5 Cabriolet, and S5 Sportback	2018 – 2023	All	Not Applicable	
RS 5	2018 – 2019 2021 - 2023	All		
RS 5 Sportback	2019 2021 - 2023

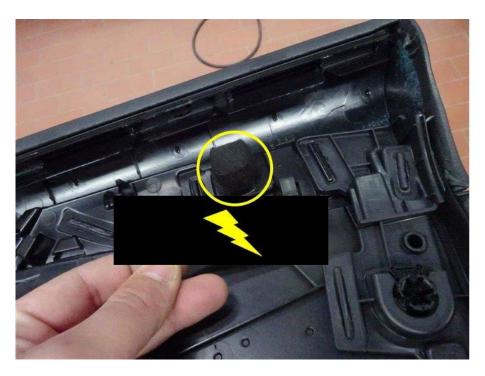
Warning: Do not apply anything to the crash element on the door trim panel or its retaining clamp on the door (Figure 2). This is strictly prohibited!

Figure 2. Incorrect application of fleece tape on crash element. Do not attach anything to the crash element or its retaining clamp!
