# Technical Service Bulletin

## 39 Oil leak at sealing cap on rear final drive, sport differential

39 22 47 2064024/2 April 29, 2022. Supersedes Technical Service Bulletin Group 39 number 21-44 dated August 26, 2021, for reasons listed below.

Model(s)	Year	VIN Range	Vehicle-Specific Equipment
S4, S5 Cabriolet, S5 Sportback, and SQ5	2020 – 2022	All	Rear Differential
S8, SQ7, SQ8, and RS Q8	2020 – 2021		
RS 5, RS 5 Sportback, and SQ5 Sportback	2021 – 2022		
RS 6 Avant, and RS 7	2021

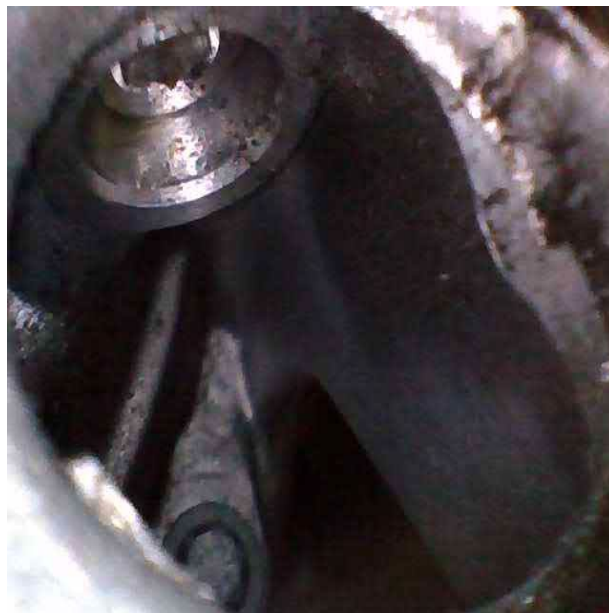
- An oil leak is confirmed from the top of the differential near the output flanges.
- One or both of the sealing caps are missing from the pressure limiting valves (Figures 1 - 3).

*Figure 1. Missing sealing cap viewed with a pocket mirror.*

If the leak can be confirmed to be from a missing sealing cap, then perform the following repair.

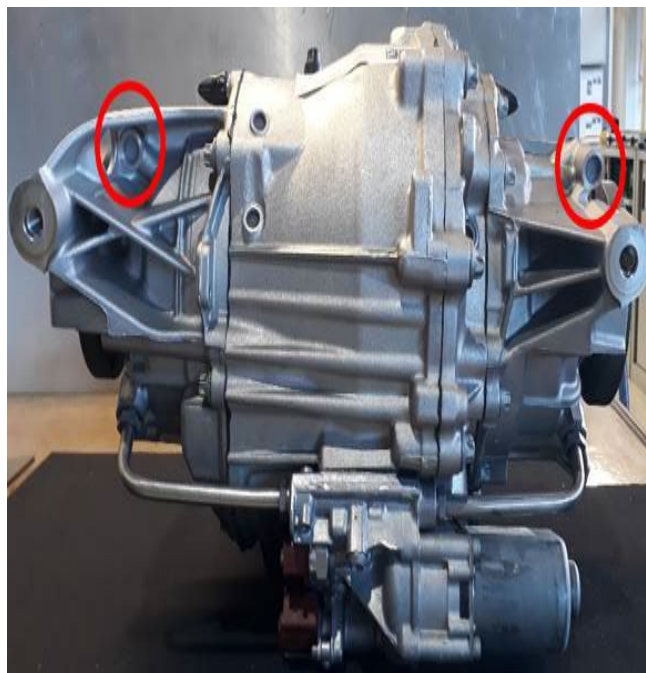
*Figure 2. Location of sealing caps on the OD3 differential.*

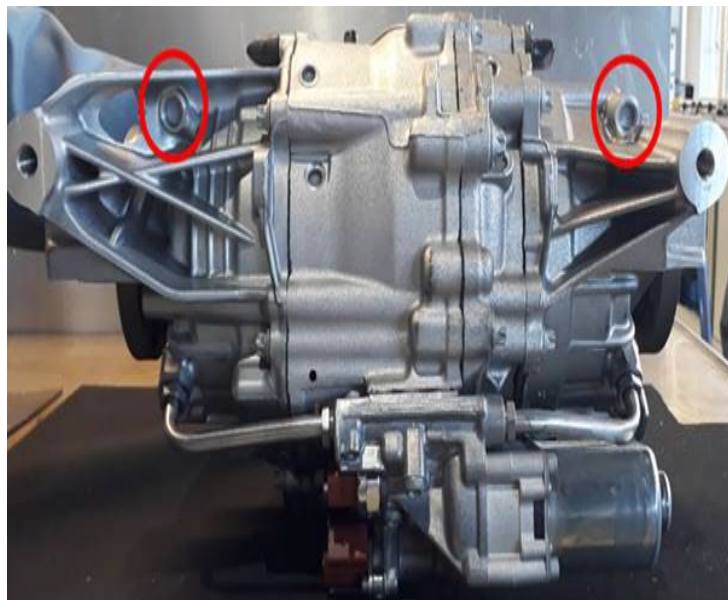
*Figure 3. Location of sealing caps on the OBX differential.*

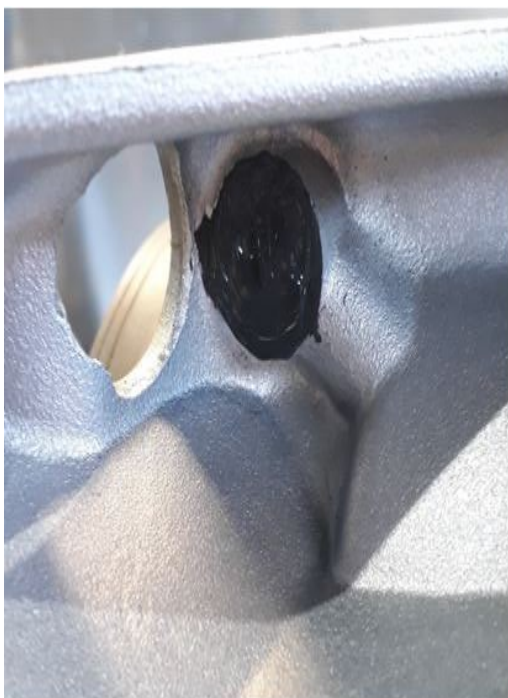
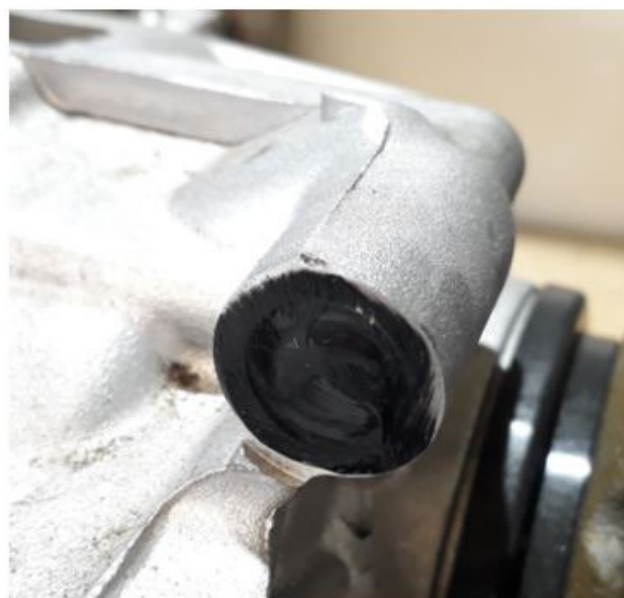
*Figure 8. Silicone adhesive sealant example 1.*

*Figure 9. Silicone adhesive sealant example 2.*

9. After a drying time of at least 30 minutes, clean the area around the sealing caps of the pressure limiting valves (both sides) using a clean cloth (lightly coated with brake cleaner if necessary).
10. Both sealing caps must be bonded over the entire surface using the silicone adhesive sealant. A layer of skin forms and then hardens (Figures 8 - 9). A drying time of at least 30 minutes must be ensured before reinstallation into the vehicle.
