# TECHNICAL SERVICE BULLETIN

## 4WD - Grinding/Rubbing Noise Under Acceleration From Floor Pan/Underbody Area

22-2161

26 April 2022

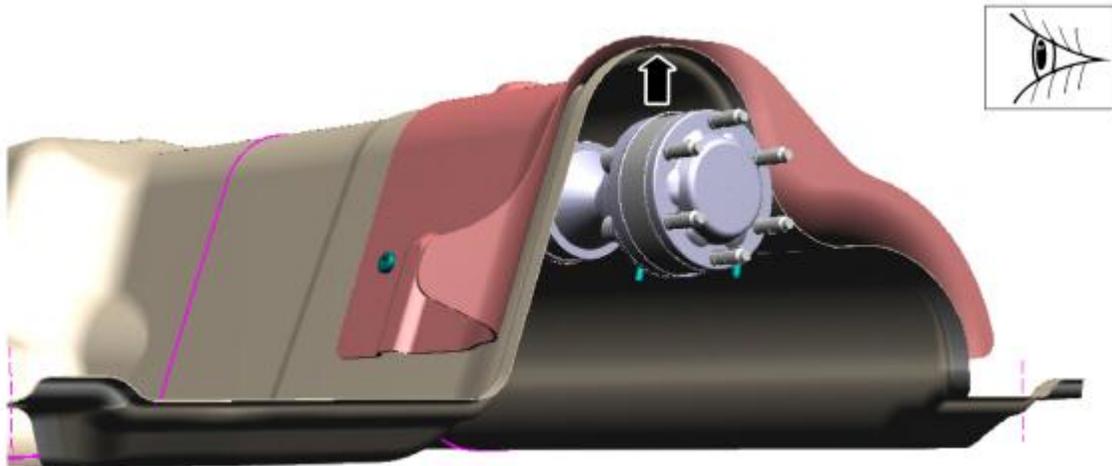
Figure 1

1. Visually inspect the fuel tank heat shield to see if there are witness marks from where the driveshaft has made contact with the fuel tank heat shield.
2. Are there signs of witness marks from the driveshaft contacting the fuel tank heat shield? (Figure 1)
  - (1). Yes - proceed to Step 3.
  - (2). No - this article does not apply. Refer to Workshop Manual (WSM), Section 100-04 for normal diagnostics.
