Authorized Field Change

AFC 21903

Subject: Heating, Ventilation, and Air Conditioning

Model: International® CV™ Series

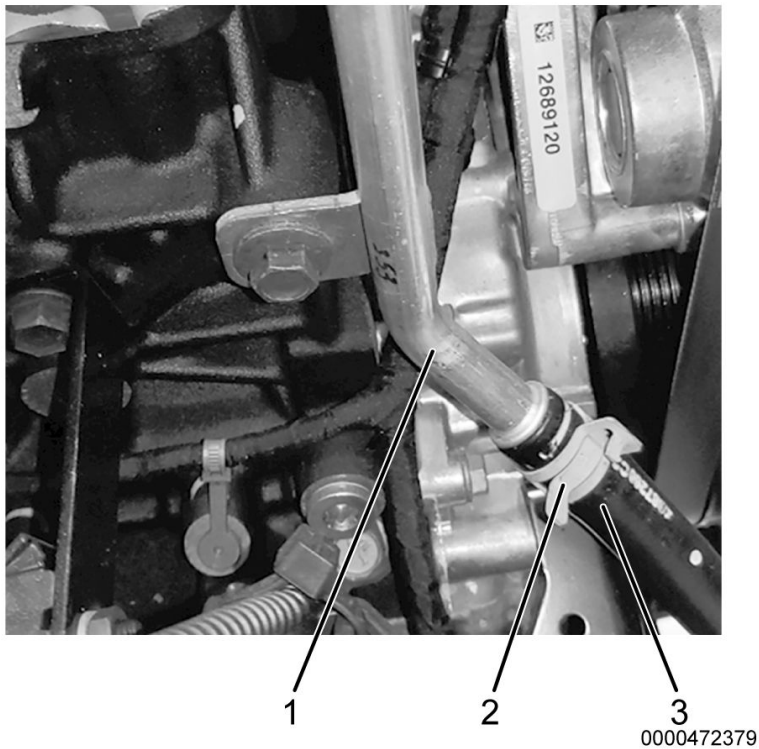
Figure 1. Reposition Lower Hose Clamp

1. Coolant pipe
2. Lower hose clamp
3. Engine hose

10. Reposition lower hose clamp (Figure 1, Item 2) below end of coolant pipe (Figure 1, Item 1) and remove engine hose (Figure 1, Item 3) from coolant pipe.

17. Install engine hose (Figure 1, Item 3) onto coolant pipe (Figure 1, Item 1) and position spring clamp (Figure 1, Item 2) to secure hose in place.
 18. Install heater core outlet hose (Figure 2, Item 1) onto coolant pipe (Figure 2, Item 3) and ensure quick connect fitting (Figure 2, Item 2) has locked onto coolant pipe.

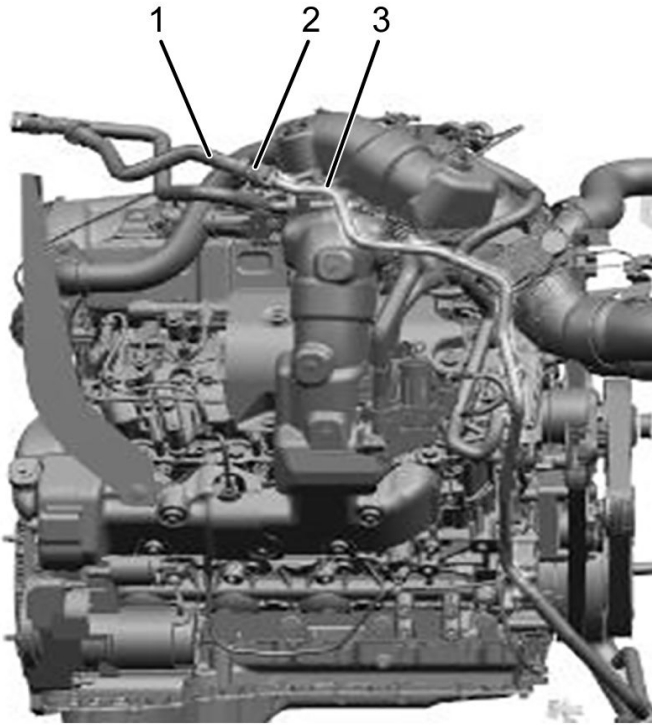
Figure 2. Unlatch Heater Core Outlet Upper Hose

1. Heater core outlet upper hose
2. Quick connect
3. Coolant pipe

11. Unlatch heater core outlet upper hose (Figure 2, Item 1) quick connect (Figure 2, Item 2) and remove hose from coolant pipe (Figure 2, Item 3).

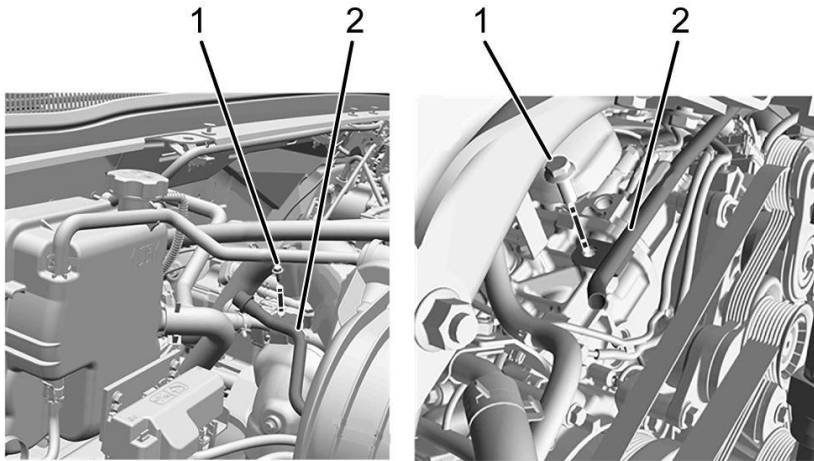
Figure 3. Remove Upper and Lower Bolts

1. Upper and lower bolts
2. Coolant pipe

12. Remove upper and lower bolts (Figure 3, Item 1) securing coolant pipe (Figure 3, Item 2) to engine and remove pipe. Save bolts for reuse and discard pipe.
13. Position new pipe into place and secure upper bracket to engine with one bolt saved in Step 12. Do not tighten bolt to specification at this time.
