WMG1 - Retrofitting Telephone Console (Smartphone Storage with Inductive Charging Function) (Workshop Campaign)

Model Year: **As of 2021 up to 2022**

Model Line: **Taycan (Y1A/Y1B)
Panamera (971)**

Concerns: **Telephone console (smartphone tray with inductive charging function)**

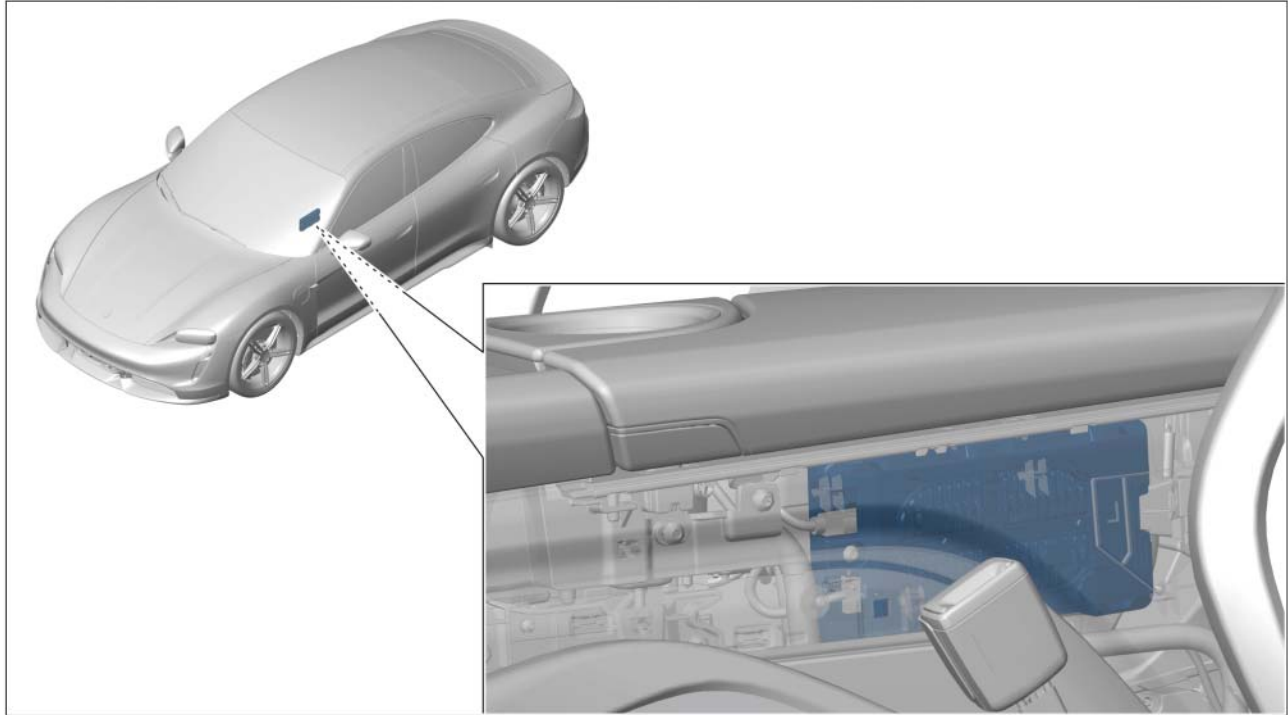
Installation position of telephone console

– Telephone console (**retrofit**)
