Bulletin #: 2116.1

Part ID: 6924

Red Warning in the Instrument Cluster: Occupant Seat Belt not Fastened

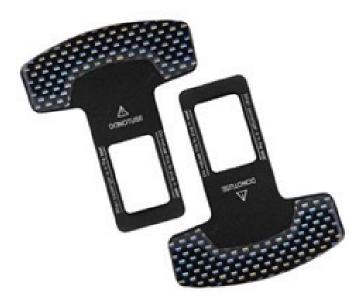
Figure 2: Example of dummy seat belt buckles

1. Document the presence of any "dummy" seat belt buckles in the vehicle with pictures.

- a) Is a "dummy" (fake) seat belt buckle ever used in the vehicle?
- b) i. Is the seat belt ever handled in a unique way? (e.g., sitting on top of buckled seat belt, placing seat belt behind seat, inserting passenger seat belt into driver belt buckle)
 - ii. Does the seat belt remain permanently fastened while the vehicle is driven?
- c) Is the vehicle ever parked for a longer period (more than a couple minutes) with the door open?
- d) Do you ever remain in the vehicle with the belt buckled and engine off (e.g., during a phone call)?
- e) What is the typical seat belt buckle fastening procedure when the operator enters the vehicle?
- f) What is the typical seat belt buckle unfastening procedure when the operator exits the vehicle?
