Taycan – Connect Services Temporarily Unavailable After Backend Migration

Models	Model Year	Model Type	VIN Range	Vehicle-Specific Equipment
Taycan	2020 - 2021	Y1A, Y1B	n/a	All

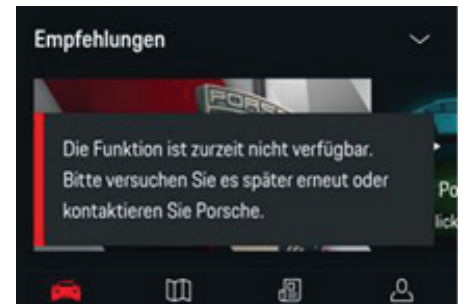
Beginning on the evening of April 25, 2022, Porsche will push an automatic update to the Connect backend. After the update, customers are likely to experience one of three "Service Temporarily Unavailable" messages in the PCM and/or smartphone app (See Figure 1.)

Figure 1: Occurrence of temporarily unavailable services in German PCM

The backend upgrade causes this issue. However, it is easy to fix. In fact, the customer can fix these issues, without visiting the workshop, by performing the steps on page 2.

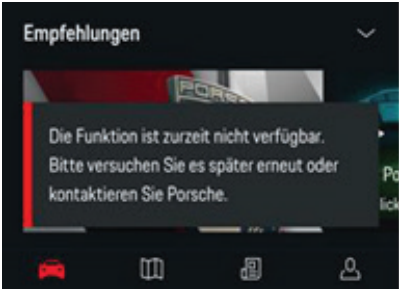
Customer Impact	Solution
<p>Remote services are temporarily unavailable after migration.</p>

<p>Solve the problem by performing one or more vehicle starts*</p>
<p>Infotainment services in the vehicle (Navigation Online, WebApps, Online Radio, Apple Music, etc.) are temporarily not available</p>

*Each vehicle start should include the locking and removal of key (>6 ft) from the vehicle for at least 2 minutes to confirm the vehicle is "asleep." This process may need to be repeated as many as 7 times in some cases.

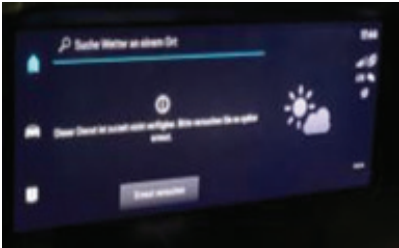
<p>Solve the problem by performing one or more vehicle starts*</p>
<p>Personalized services are temporarily unavailable after migration</p>

<p>Solve the problem by changing the user login</p>
