## Body Compartment Lighting Inspection

**Units Affected:** Certain Altec aerial devices, digger derricks, and body-only units built from 2014 to 2021. Verify your unit is affected by reviewing the attached list or accessing Altec Connect.

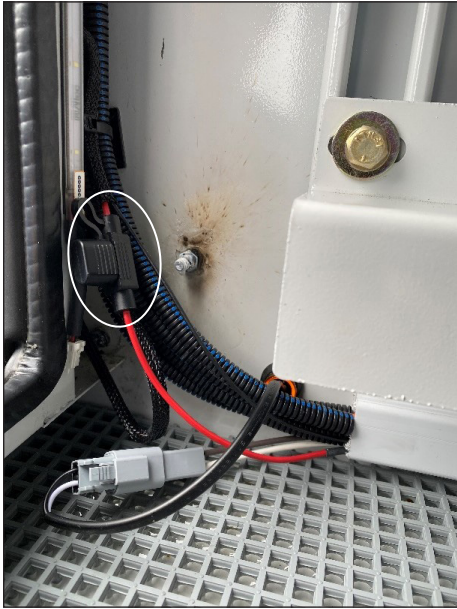
**Figure 1 — In-Line Fuse**

1. Position the unit on a level surface, apply the parking brake, and turn off the engine. Remove the key from the ignition, and secure it following your employer’s vehicle lockout/tagout procedure. Chock the wheels.
2. Inspect to see if an in-line fuse as shown in Figure 1 is installed in the wiring for the lighting in the applicable body compartments listed in Figure 3. Record the inspection results in Figure 3, including the total number of lighted compartment locations having no fuse installed.

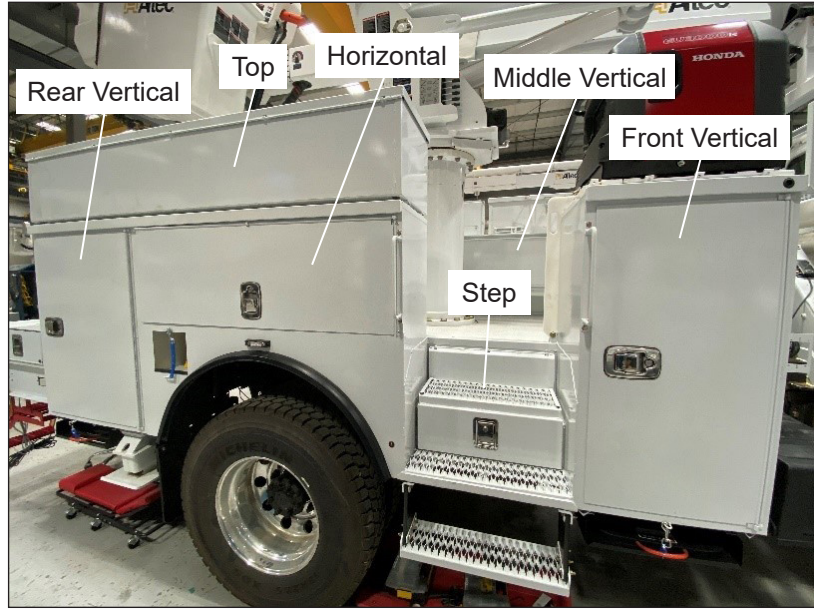
**Figure 2 — Body Compartments**

**Background:** The body compartment wiring on some units contains an in-line fuse located close to the lighting in the compartment, while other units are fused upstream, closer to the power source. Altec has learned that the units affected by this SIL should have an in-line fuse close to the lighting, but this fuse was not installed on some units. In addition, some units may have exposed terminals at the end of certain portions of the wiring in the body. If the exposed terminals make contact with each other or with ground, the resulting direct short could damage the body compartment lighting.
