**2021 E-Hybrid OBC Fault U112100 DTC D1211D “Data bus - missing message”**

Models	Model Year	Model Type	VIN Range	Vehicle-Specific Equipment
Cayenne	2021	E-Hybrid and Turbo S E-Hybrid, All Variants	N/A	KB2 - 7.2 kW On-board Charger
Panamera	2021	E-Hybrid and Turbo S E-Hybrid, All Variants	N/A	KB2 - 7.2 kW On-board Charger

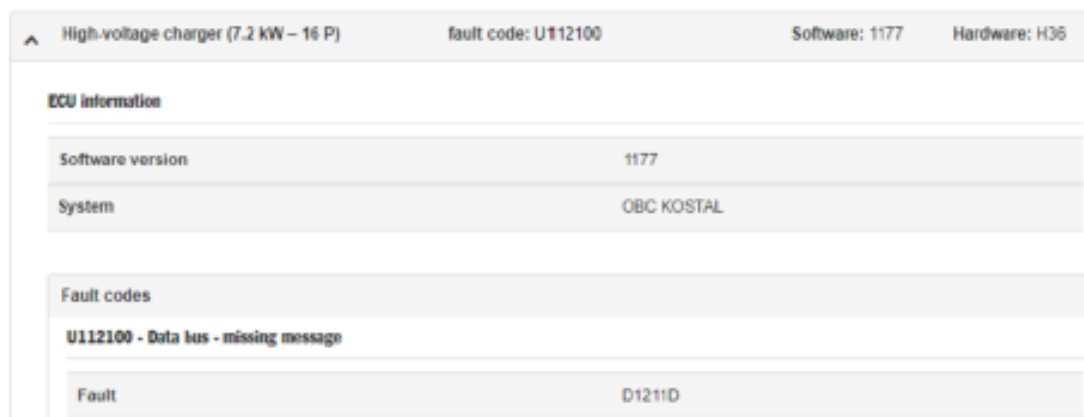
Figure 1

The customer reports the Check Engine Light (CEL) / Malfunction Indicator Light (MIL) is illuminated upon vehicle startup. The 7.2 kW On-Board Charger (OBC) has stored Fault Code U112100, DTC D1211D “Data bus – missing message” (Figure 1).

A software timing & synchronization error exists in 7.2 kW OBC software version 1177. This can result in delayed control unit communication and the subject fault code which then causes illumination of the MIL.

The OBC software should be updated from version 1177 to 1183 to permanently remedy the communication issues causing FC U112100 DTC D1211D "Data bus – missing message".

Campaign Code **E3S3U** updates subject Cayenne E-Hybrid OBC from SW 1177 to 1183.

Campaign Code **G2S3U** updates subject Panamera E-Hybrid OBC from SW 1177 to 1183.

Following update of the OBC, erase all fault codes and verify normal vehicle operation.
