Service Bulletin

Bulletin No.: 22-NA-071

Subject: 2022 Tahoe, Suburban, and Yukon Radio Update

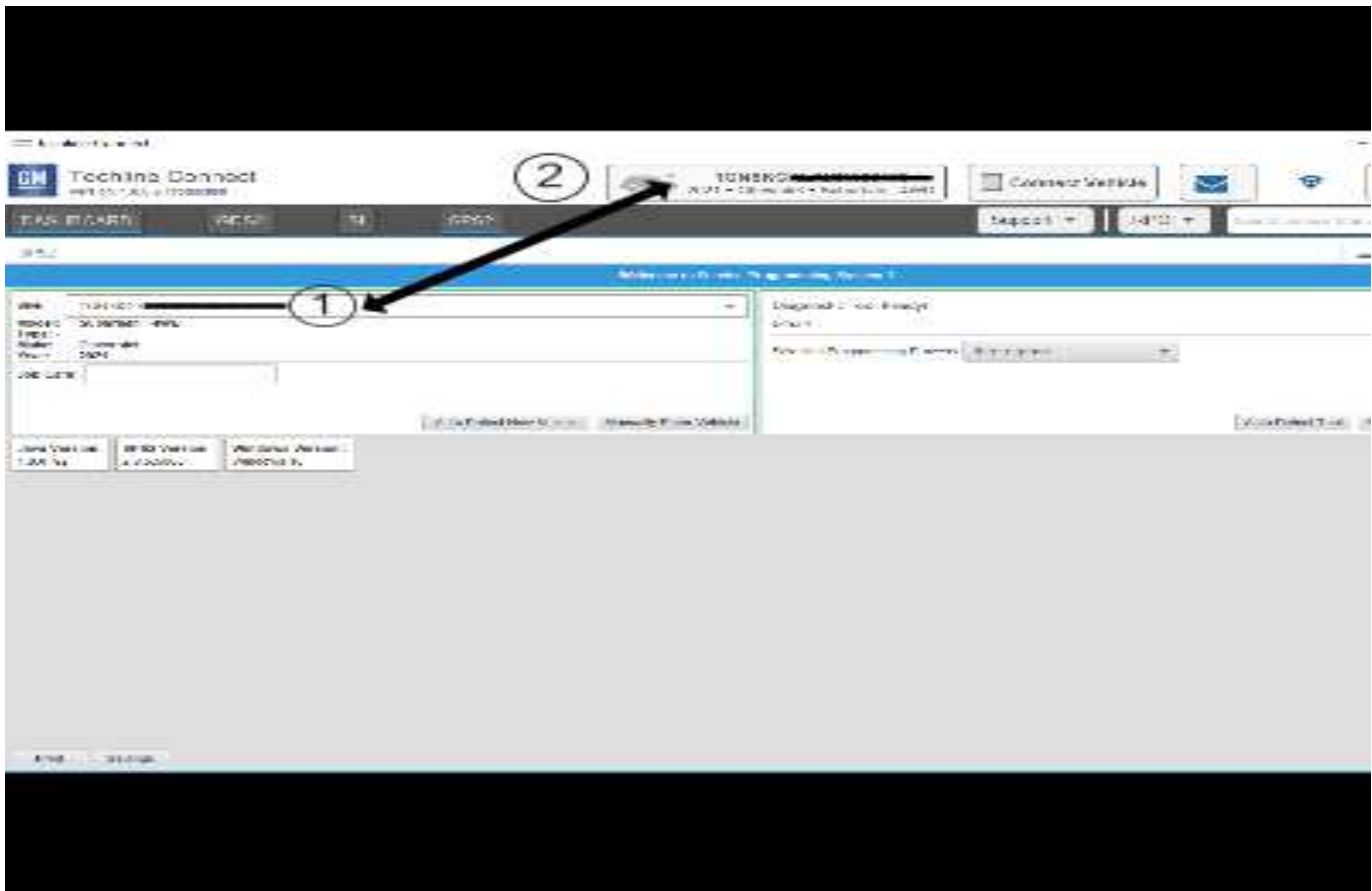
Caution: Be sure the VIN selected in the drop down menu (1) is the same as the vehicle connected (2) before beginning programming.
