Service Bulletin

Bulletin No.: 22-NA-080

Subject: Diagnostic Tips for Engine Related Shudder Concerns

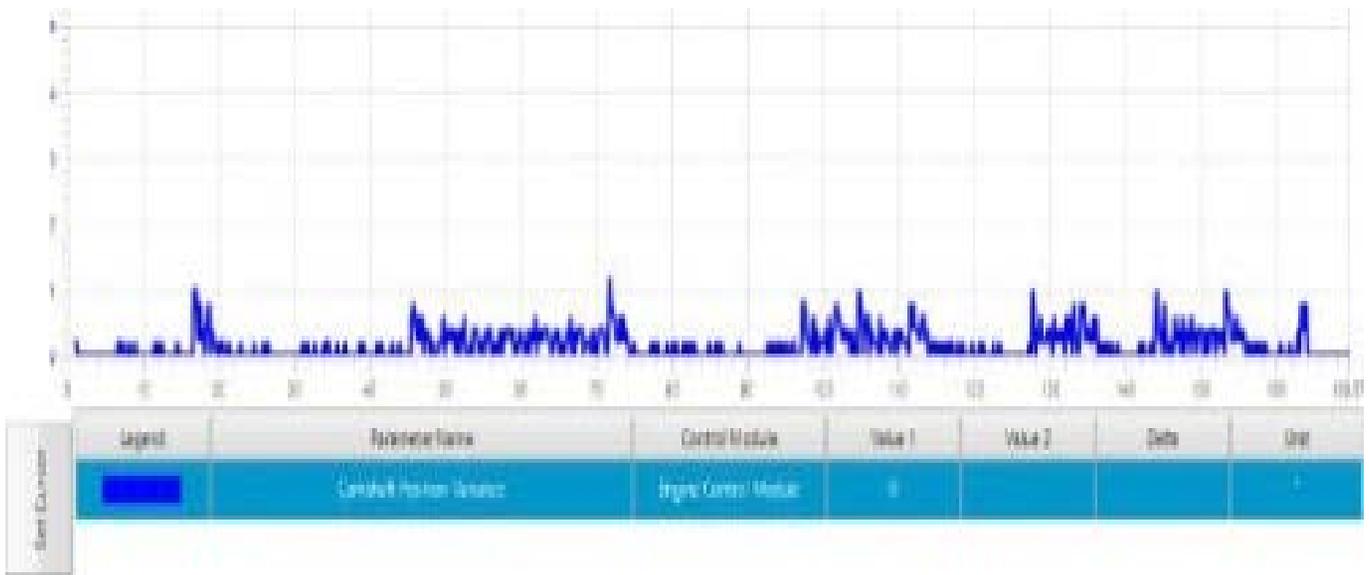
Normal operation (variance under 4 degrees)

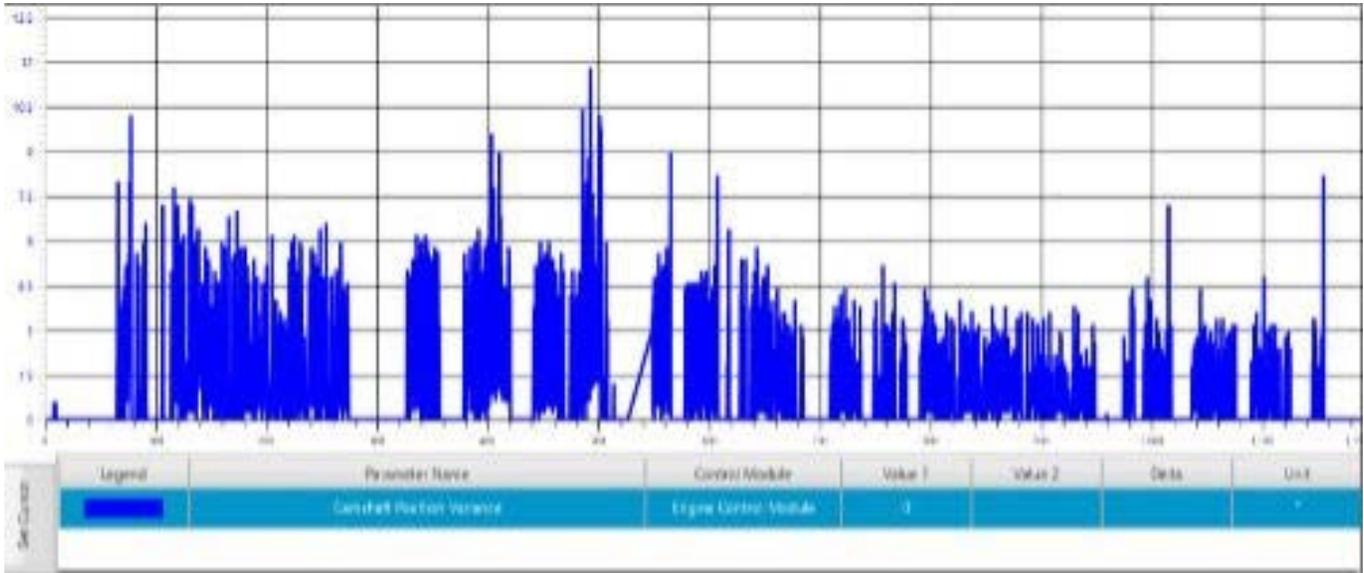
6029096

Suspect fault in camshaft actuator system (variance over 4 degrees)

Causal Part	Description	Part Number	Qty
X	MAGNET, CM/SHF POSN ACTR	12675031	1
