## Service Alert

Subject:	
INFOTAINMENT SUB-WOOFER RATTLE NOISE	Service Alert No.: SA-024/22
	Last Issued : 04/27/2022

2019-2022 Mazda3

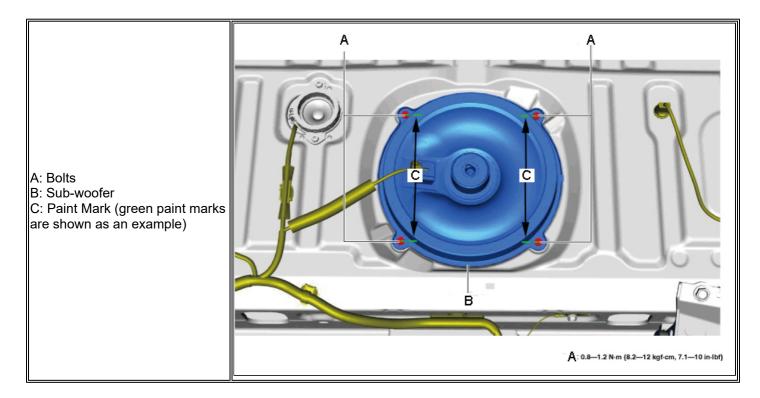
Some customers may experience an infotainment sub-woofer rattle noise. Follow the repair procedure to help determine the cause.

- 1. Verify the customer concern.
- 2. Document the following:
  - · Infotainment Source
    - Radio, Bluetooth, Apple Carplay / Android Auto.....etc.
  - If song is playing,
    - Artist?
    - Name of song?
  - · Infotainment volume level?
    - If volume is lowered, does rattle noise disappear?
  - · Infotainment bass level?
    - If bass is lowered, does rattle noise disappear?
  - Vehicle parked or driving?
    - If driving, document vehicle speed, street or highway, concrete or asphalt?
  - If possible, record a video of the rattle noise.
- 3. Apply paint marks (C) to speaker bolts (A) and sub-woofer (B) as shown below:

- 4. Set torque wrench to 7.1 in-lbs.
- 5. Turn torque wrench clockwise and document if clicker engages or bolt moves.
  - · If clicker engages and bolt does not move, the bolt torque is good.
  - If the bolt paint mark moves clockwise, the bolt is loose.
- 6. Contact Hotline and provide inspection results.
