Subject: AIR BAG WARNING WITH DTC B1126:13 OR B1127:13	Bulletin No.: 08-002/22
	Last Issued : 04/22/2022

2020-2022 CX-30

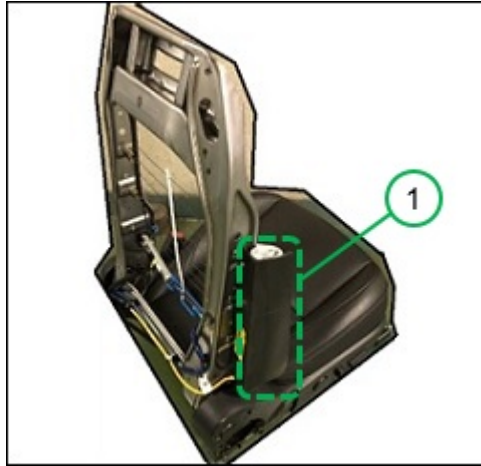
- When the driver or passenger moves, a load is applied to the seat back and the load may cause displacement of the mating terminals in the side air bag module connector, resulting in insufficient contact and higher resistance.
- The DTC detection level is too sensitive.

1. Verify the customer concern.
2. **[For vehicles with VINs lower than 3MVDM*****414338 (produced before Feb. 27, 2022)]** Replace the affected side of the side air bag module(s) (1) with modified one(s) according to instructions on MGSS.
 - US/Canada spec: (SIDE AIR BAG MODULE REMOVAL/INSTALLATION [TWO-STEP DEPLOYMENT CONTROL SYSTEM - US/CANADA SPEC.])
 - Mexico spec: (SIDE AIR BAG MODULE REMOVAL/INSTALLATION [STANDARD DEPLOYMENT CONTROL SYSTEM - MEXICO SPEC.]
