RCA-78-22-005-1: Increase Clearance between Cowl Harness and Steering Column

Document Type	Customer Satisfaction Campaign Bulletin
Date	April 12, 2022
Affected Region(s)	USA
Affected Model(s)	R1T
Model Year(s)	2022
Approximate Build Dates Refer to the FSA Dashboard to determine if this document applies to a specific vehicle.	August 2021 - December 2021
Vehicle System	78 - Low Voltage Electrical
Minimum Service Location	Mobile

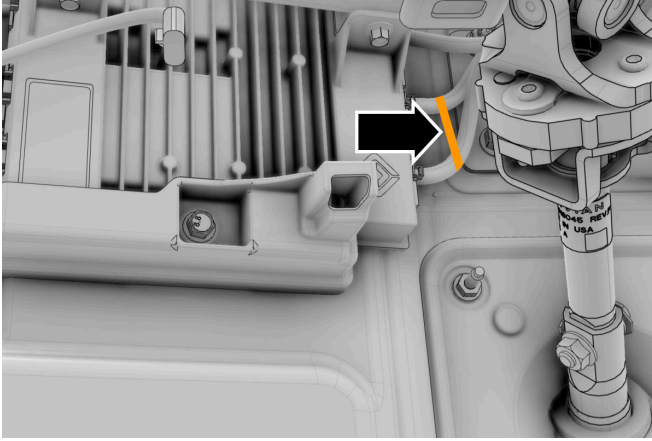
Rivian is initiating a customer satisfaction campaign for some model year 2022 R1T vehicles that may have been built with a low clearance condition between the cowl harness and the steering column. If the cowl harness touches the steering column and this condition persists over time, the vehicle may experience a wear-through condition of the wires in the cowl harness. The potential wear-through condition may affect the steering angle sensor and/or turn signal wiring. If the steering angle sensor wiring is affected, the vehicle will enter into a reduced performance safe-state mode and a "Limited Performance Mode" indicator light will illuminate on the driver display alerting the driver to have service performed on their vehicle. If the turn signal wiring is affected, the turn signals may not properly function and a fault indicator light will illuminate on the driver display alerting the driver to have service performed. Rivian will install a cable tie to ensure clearance between the cowl harness and the steering column. Rivian is launching this campaign for customer satisfaction and to ensure the quality of Rivian vehicles.

2. Install: Cable tie. Tighten the cable tie enough so that the harness can not contact the steering column.
