Technical product information

Topic	Vehicle sitting low on one or more corners when static with no relevant DTCs stored
Market area	Russische Föderation (5RU),Australia E04 Bentley rest Asia and Australia (6E04),China 796 VW Import Comp. Ltd (Vico), Beijing (6796),Germany E02 Bentley rest Europe (6E02),Japan E03 Bentley Japan (6E03),Korea, (South) E08 Bentley South Korea (6E08),United Arab Emirates E06 Bentley Middle East and Africa (6E06),United Kingdom E01 Bentley UK (6E01),United States E05 Bentley USA and rest America (6E05)
Brand	Bentley
Transaction No.	2064582/3
Level	EH
Status	Approval
Release date

New Continental GT and New Continental GTC

New Flying Spur

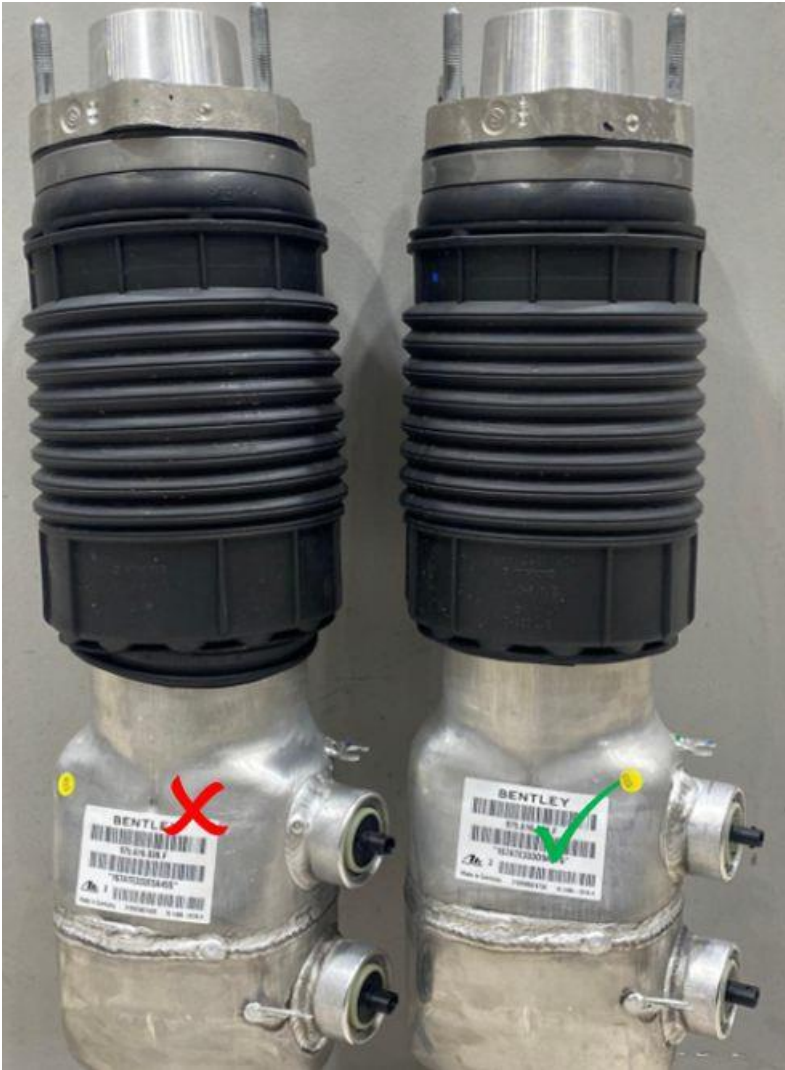
8) Referring to Figure 3 - Inspect the left and right hand front air springs checking for any signs of damage and/or distortion

NOTE: Figure 3 shows the left hand front air spring damper distorted

- In the event an issue is found with the left and/or right air spring damper - Refer to Rep.Gr 40 - Replace the left and right hand front air spring dampers

Within the front air spring damper procedure there are single use items which must be replaced and not reused. Ensure that new replacements are available prior to starting this procedure - Refer to the ETKA parts catalogue
