Technical Service Bulletin

SUBJECT: DEW CONDENSATION IN HEADLIGHTS AND TAILLIGHTS		No: TSB-22-54-003	
		DATE: APRIL 2022	
		MODEL: All Models	
CIRCULATE TO:	<input type="checkbox"/> GENERAL MANAGER	<input checked="" type="checkbox"/> PARTS MANAGER	<input checked="" type="checkbox"/> TECHNICIAN
<input checked="" type="checkbox"/> SERVICE ADVISOR	<input checked="" type="checkbox"/> SERVICE MANAGER	<input type="checkbox"/> WARRANTY PROCESSOR	<input checked="" type="checkbox"/> SALES MANAGER

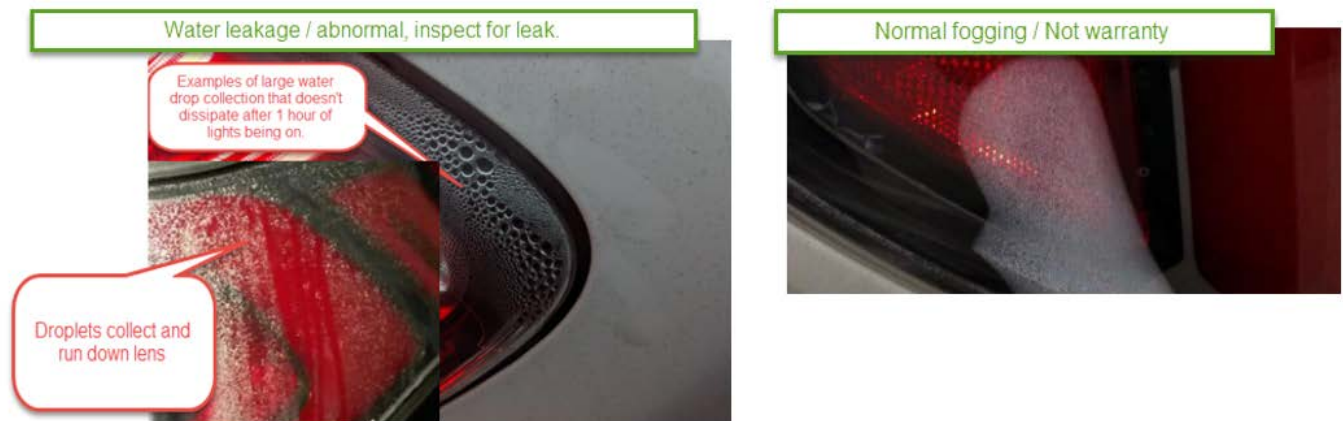
Atmospheric air contains moisture even in fair weather. Higher temperature air can contain a large amount of moisture, but when the temperature drops, the amount of contained moisture decreases and the moisture that is left becomes dew condensation. This principle is demonstrated in a fogged car windshield or windows on a house. The window is heated by the warmer indoor air, which contains more moisture than the colder air outside. The window is cooled by the colder outside air, which causes the warmer air on the inside of the window to cool, and release moisture in the form of dew condensation.

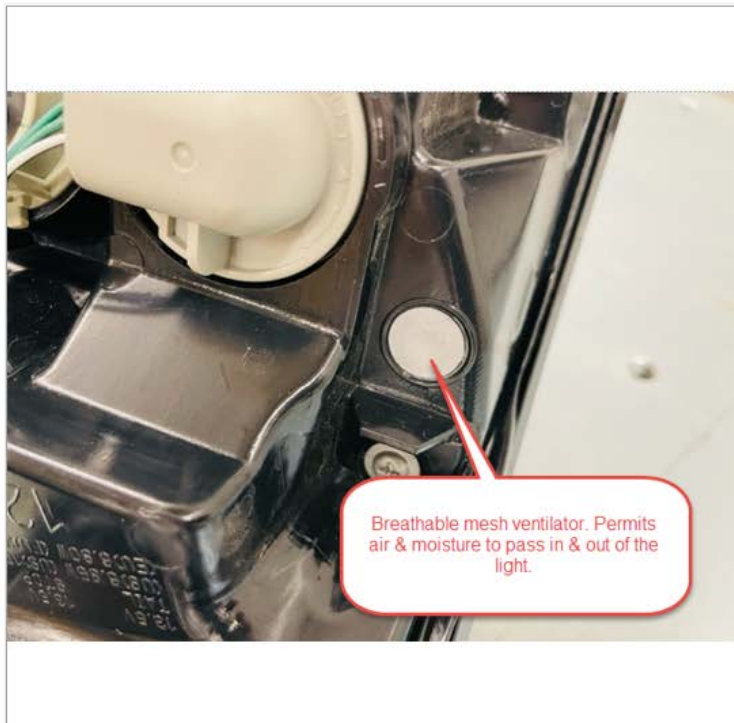
Dew Condensation/Fogging of Headlights and Taillights

Headlights and taillights become fogged as part of a normal dew condensation process.

When the light is on, it generates heat, and air inside of the housing expands and contracts as the lights are turned on and off. The housing of headlights and taillights are designed with breathing holes that allow ambient air to flow into and out of the light housing. This design helps to prevent cracks and damage to the seal from pressure fluctuation.

When air outside of the light unit is humid, the moisture enters the light housing through the breathing holes as the light is turned on and off.

While some of the suctioned moisture dissipates, some of it stays inside the unit. In addition, resin materials of the light itself release moisture into the light unit as temperature rises. This warmer residual moisture becomes dew condensation when it contacts a cooler lens (for example, a lens that has been cooled by rain or washing the vehicle).
