HYUNDAI Technical Service Bulletin

GROUP STEERING	NUMBER 22-ST-003H
DATE APRIL 2022	MODEL(S) Sonata (DN8A)

SUBJECT: SONATA (DN8A) C-MDPS WORM SHAFT BEARING NOISE

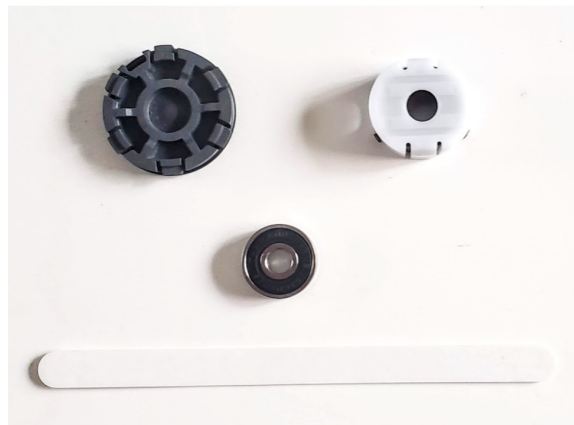
Description: Certain 2020-2022MY Sonata (DN8A) vehicles may develop a bearing noise within the Motor Driven Power Steering (MDPS) column worm shaft assembly. If bearing noise is heard, follow the procedure in this bulletin to replace the worm shaft bearing.

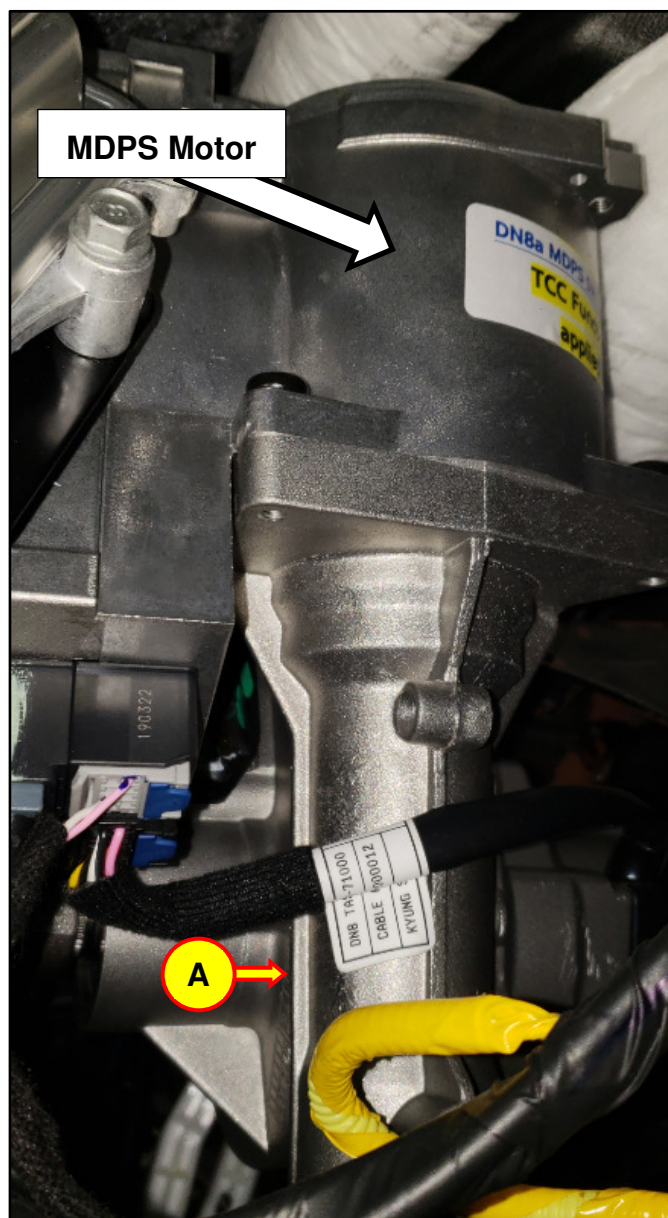
1. Determine if bearing noise comes from the MDPS column and housing.
 - Start the engine and turn the steering wheel left and right.
 - Listen for the bearing noise occurring from the worm shaft housing (A). This noise will be located near the C-MDPS motor on the steering column.
 - To hear an example of the bearing noise, refer to the link or QR code below.
<https://youtu.be/22PI3hAEfnk>

2. Replace the worm shaft small bearing if noise is heard.

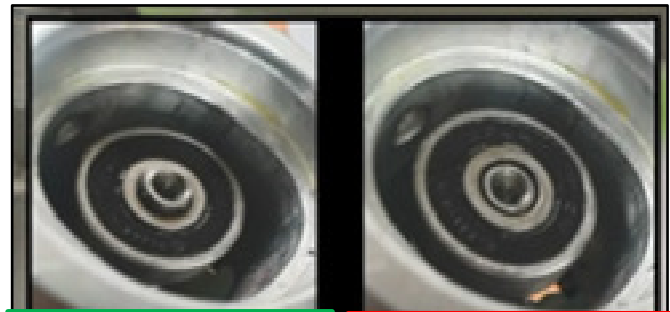
Ensure the bearing is fully seated and the end of the worm shaft is protruding approximately 1.2mm (0.047 inch).

OK
Bearing is seated properly. The end of the worm shaft is protruding.

Not OK
Bearing is not seated properly. The end of the worm shaft is flush with the bearing.

If the bearing did not seat as shown in the photo, increase the torque setting on the torque wrench and continue to slowly seat the bearing.
