# TECHNICAL SERVICE BULLETIN

Technical Service Bulletin: 205-1511

Forest River is alerting you to an issue involving certain 2022 Coachmen Catalina Travel Trailer recreational vehicles. Please see the information below which describes the issue and provides you with details on the steps you should take to have your vehicle repaired.

# TECHNICAL SERVICE BULLETIN 205-1511 REMEDY INSTRUCTIONS

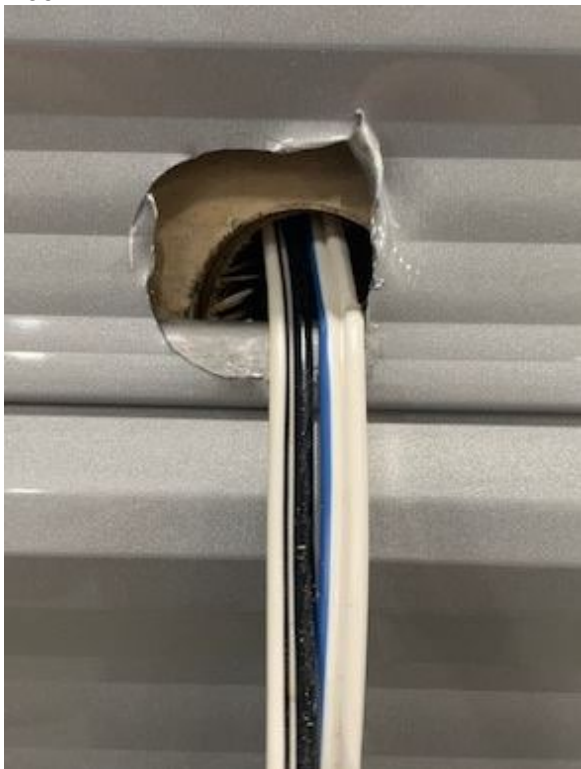
FIGURE 1

The hole where the 12V wires exit the vehicle skin and connect to the awning might not be sealed with silicone.

STEP 2: LOCATE THE HOLE WHERE THE 12V WIRING EXITS THE VEHICLE BODY INSIDE THE AWNING ARM (FIGURE 1);

STEP 3: LIBERALLY APPLY CLEAR OR BLACK SILICONE SEALANT INTO THE HOLE, UNTIL FULL AND WIRES ARE SEALED;
