Subject: N222359630 - Customer Satisfaction Program  
Rear Body Floor Pan Metal Split

Models: 2022 Cadillac XT4

# Customer Satisfaction Program

## N222359630 Rear Body Floor Pan Metal Split

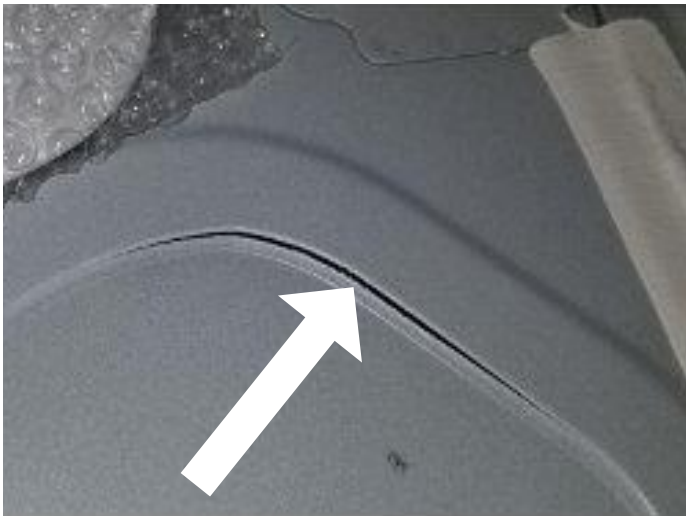
6052768

3. Locate the depression in the right-side floor area.

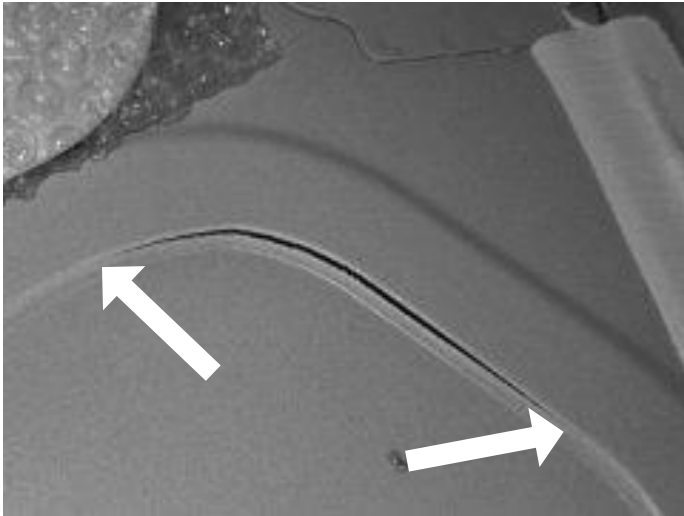
6052781

4. Inspect the area for cracking.
  - If no cracking is found, no further action is required. Reinstall the rear compartment trim.
  - If cracking is found, proceed to step 5. These steps will involve mitigating the spread of the crack and installing a metal overlay to seal and reinforce the area.

5. Drill a 3.2mm (1/8 in.) hole at both ends of the crack. This will stop the crack from spreading.
