Technical Service Bulletin

Transaction No: 2034898/21

01-18-13 - MIL ON DTC P0401, **P2002 or P240F** Exhaust Gas Recirculation Flow Insufficient

Release date: 5/3/2022

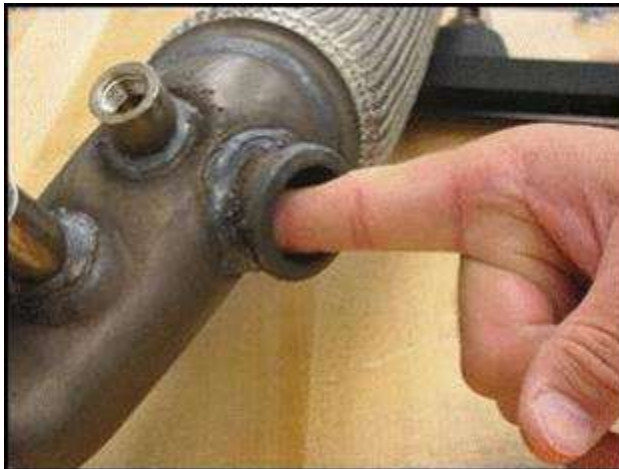
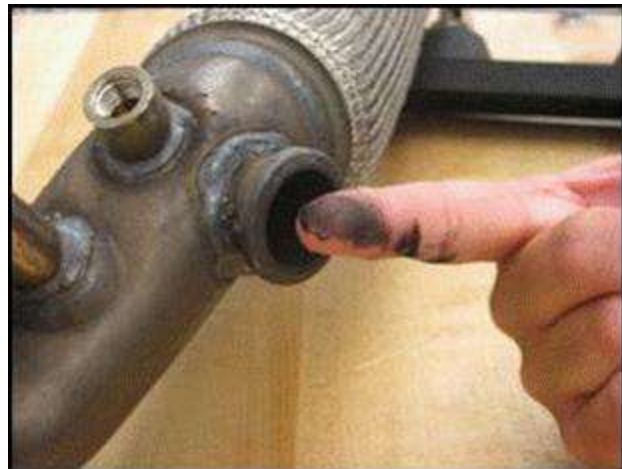
High soot loads prior to regeneration can cause possible restrictions in the Exhaust Gas Recirculation (EGR) filter.

- Remove the EGR filter from the Diesel Particulate Filter (DPF) and swipe the inside of the exhaust pipe at the EGR filter connection point using a clean cloth or your finger. See figures 1 and 2 below.

If your finger or the cloth comes out with black soot:

- Replace the DPF & EGR filter together. The engine must be running correctly with no faults stored to perform the next steps.
- Read out 01 ECM control module OBD Basic Settings block 67 with engine at idle and at operating temperature. If the MAF actual value is equal to or greater than 540 mg/h, proceed to smoke testing below (there is likely a leak within the intake system). If the value is less than 540 mg/h, proceed to inspection of the snow flap and air filter (TSB attachment). There is no need to smoke test.
- Smoke test the charge air system for leaks if MAF value is 540 or greater (see procedure below).

When replacing the DPF for faults P0401, P2002 or P240F it is important to replace both the DPF and the EGR filter together, as soot accumulation in the EGR filter is undesired. It is NOT necessary to replace any other components for this fault (i.e. NOx Storage Catalyst, Sulfur Catalyst, Exhaust Flap, EGR cooler) Cooler). These components should be reinstalled in the vehicle with the new DPF and EGR filter. If the particulate filter was replaced, an adaptation must be performed in Guided Functions. Refer to Tech Tip TT 26-13-02 (2035501).

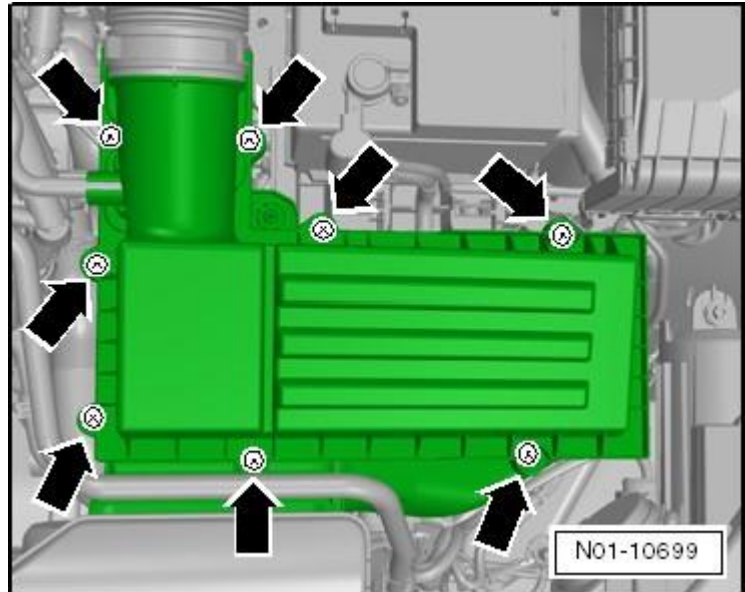
- Raise air filter upper section and remove airfilter element -1-.
Inspect air filter and if too contaminated with debris, advise customer to replace (non-warranty claimable item).
