Service Bulletin

Bulletin No.: 18-NA-114

Subject: Intermittent Service All Wheel Drive (AWD)/Service Stability Messages and/or Low Oil Pressure Shut Off Engine Message Displayed in Driver Information Center (DIC), Erratic Speedometer Readings, No Crank, Malfunction Indicator Lamp (MIL) Illuminated - DTC P0641, P2535, U0073, U0100, U0101, U0121, U0131, U0136 and/or U1814 Set

Brand:	Model:	Model Year:		VIN:		Engine:	Transmission:
		from	to	from	to		
Chevrolet	Trax	2018	2020	—	—	1.4L (LUV)	—

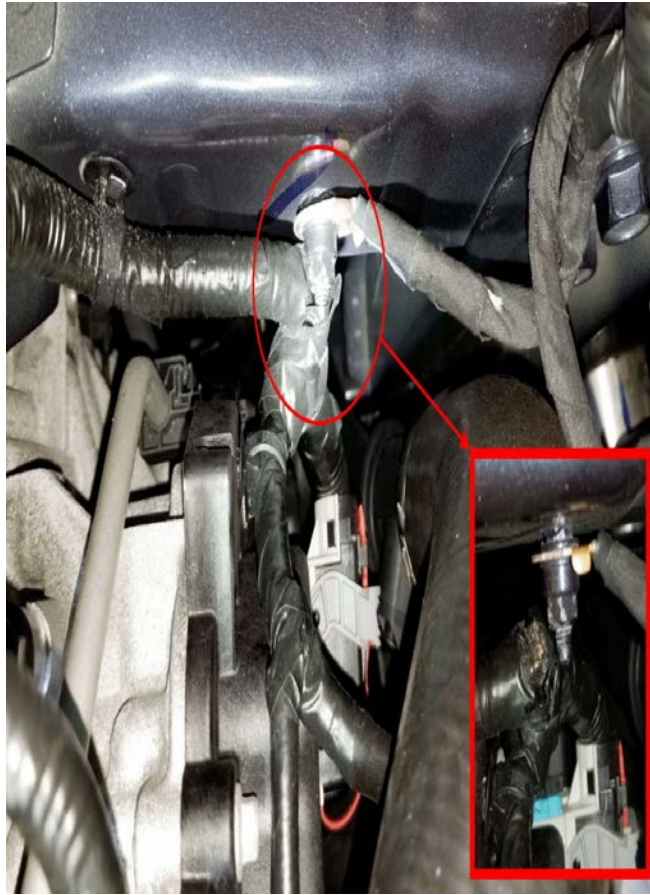
5040432

Cause	<p>Note: This is a multi-wire bundled harness and, depending on which wire is damaged, can set a variety of DTCs.</p> <p>This condition may be caused by the engine harness chaffing against the G100 Ground stud.</p> <p>This condition may be caused by damage to the engine harness near the X112 connector.</p> <p>⇒ Inspect G103 (refer to bulletin 19-NA-068)</p>

1. With a suitable light, inspect the wiring harness point of contact at the G100 ground stud.
- ⇒ For stud location, refer to Document ID#: 4708510 in SI.
2. Repair the harness as needed.
- ⇒ Refer to *Wire to Wire Repair* in SI.
