Technical Service Bulletin

GROUP CAMPAIGN	NUMBER 22-01-037G
DATE APRIL, 2022	MODEL(S) G80 (RG3)

SUBJECT: REAR CORNER RADAR VARIANT CODING
(SERVICE CAMPAIGN T22G)

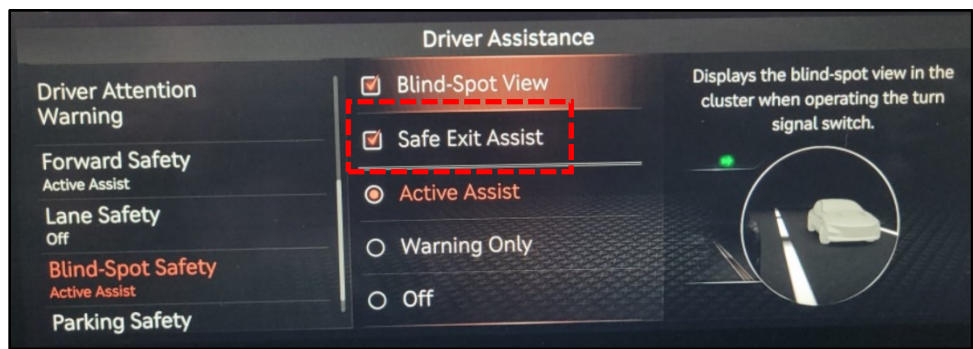
Description: Certain 2022MY Genesis G80 (RG3) non-Sport vehicles may exhibit a condition where the Safe Exit Assist is not available in the Driver Assistance Setting.

This bulletin provides the service procedure to variant code the rear corner radar using the GDS to resolve the condition stated above.
