Technical Service Bulletin

10 Engine cover is loose or rattles

10 22 23 2057260/3 May 11, 2022. Supersedes Technical Service Bulletin Group 10 number 19-17 dated December 20, 2019, for reasons listed below.

Model(s)	Year	VIN Range	Vehicle-Specific Equipment
RS 5	2018 – 2019	All	Not Applicable
RS 5 Sportback	2019

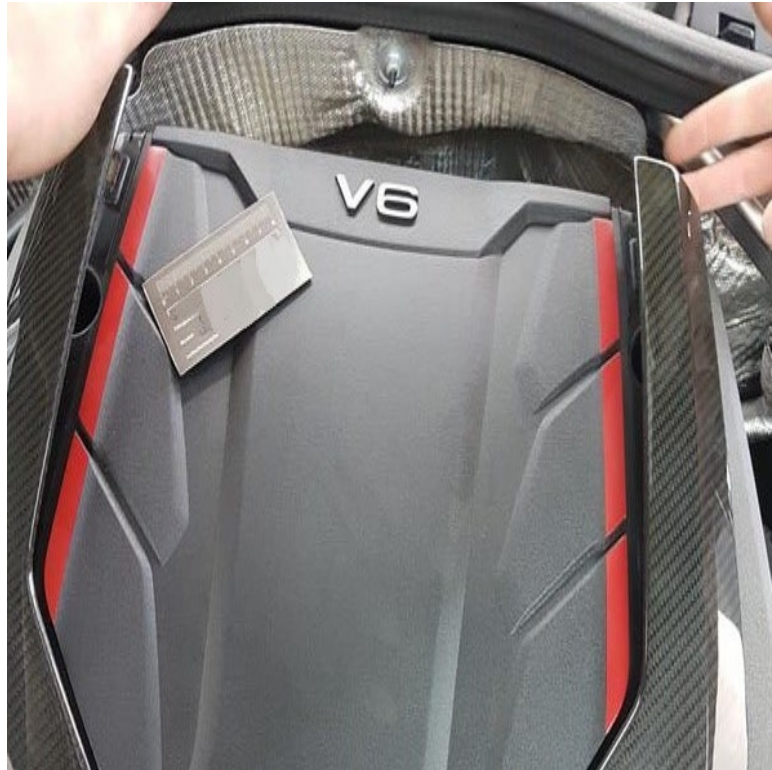
- Rattling noises from the engine compartment and the trim panel comes off the engine compartment cover (Figure 1).

Figure 1. Engine compartment cover.

Bond the engine compartment cover and the trim panel as described below:

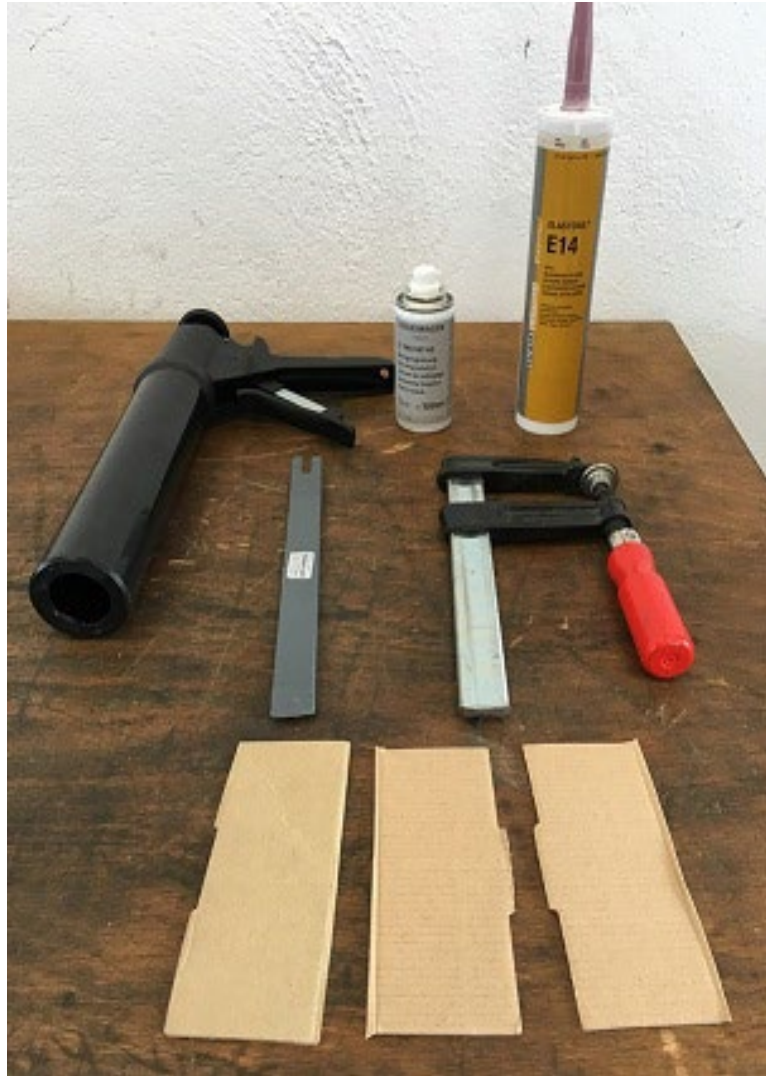
Figure 2. Required tools.

Required Shop Tools (Figure 2):

- Plastic wedge
- Adhesive tape
- Cleaning solution G 065 567 A2
- Cartridge press
- A moisture-curing, silicone-rubber-based adhesive (RTV-1 silicone) must be used. For example:
 - Elastosil E14 silicone rubber (Wacker)
 - Super RTV silicone, item no. 08933312 (Würth)
- Cardboard
- Screw clamp

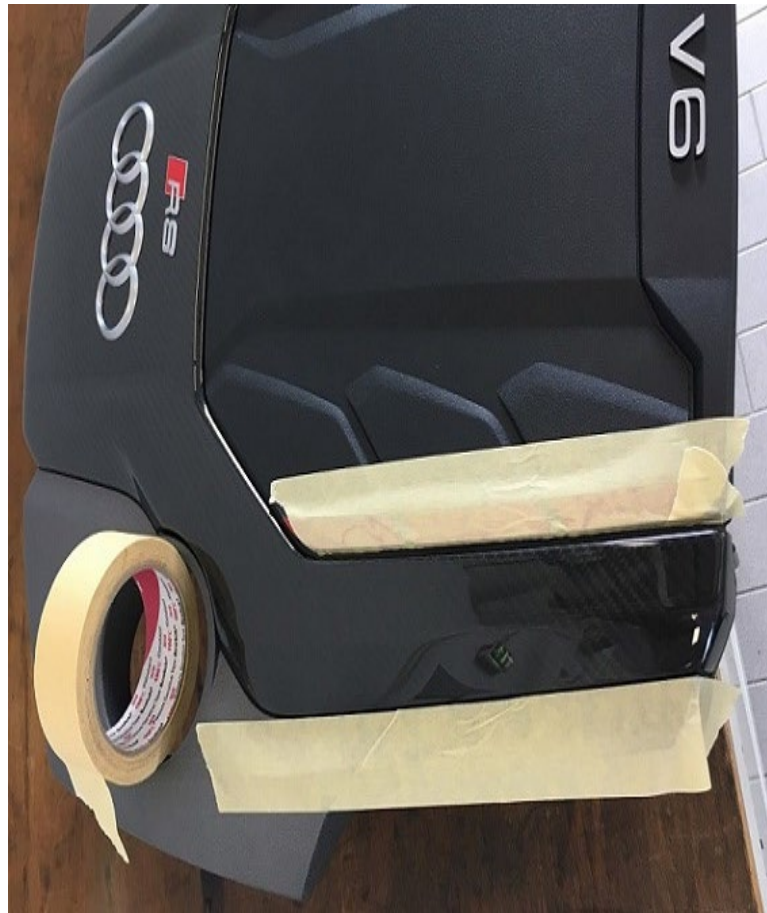
Figure 3. Masking the engine compartment.

1. Mask the engine compartment cover in the area of the trim panel (Figure 3).

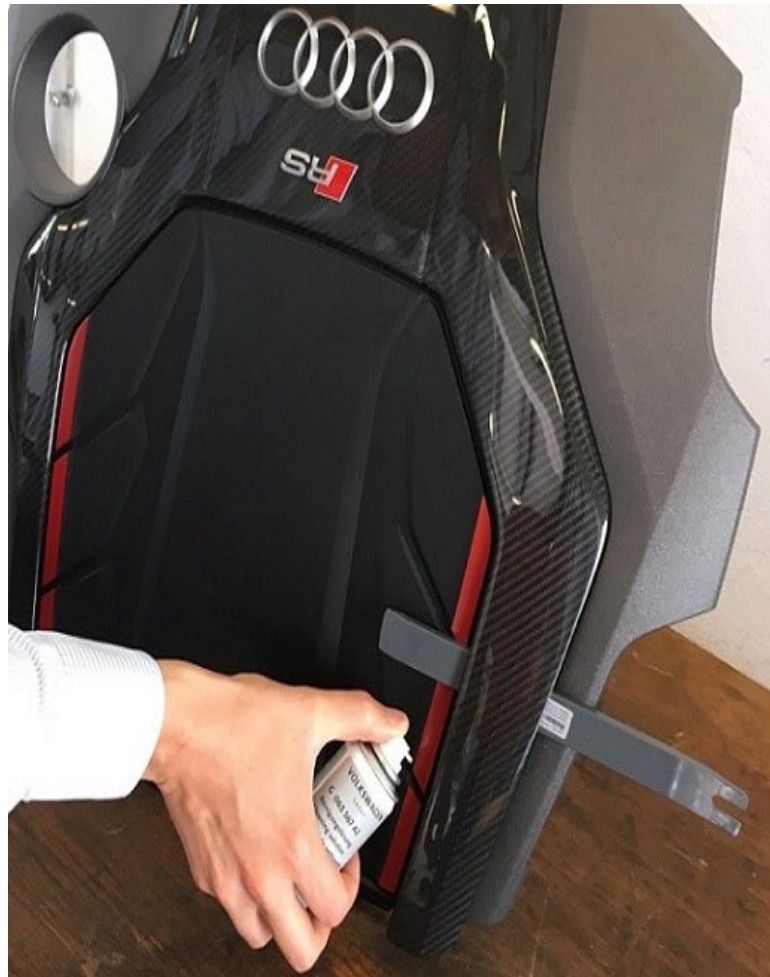
Figure 4. Lift the trim panel and clean.

2. Carefully lift the trim panel with a plastic wedge and clean the bonding surfaces (Figure 4).

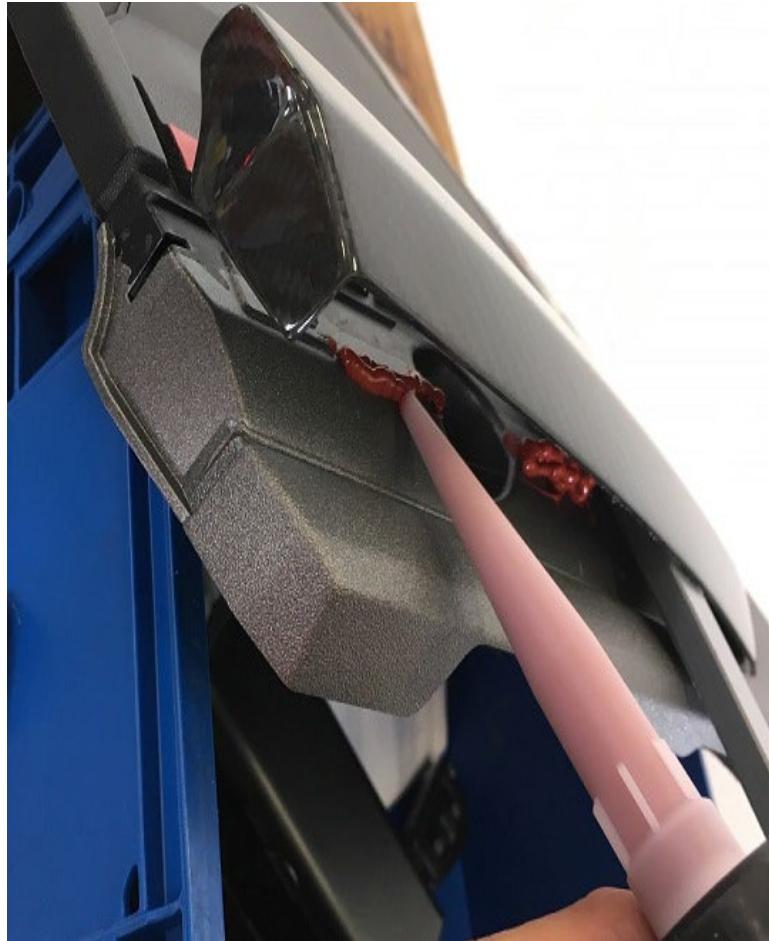
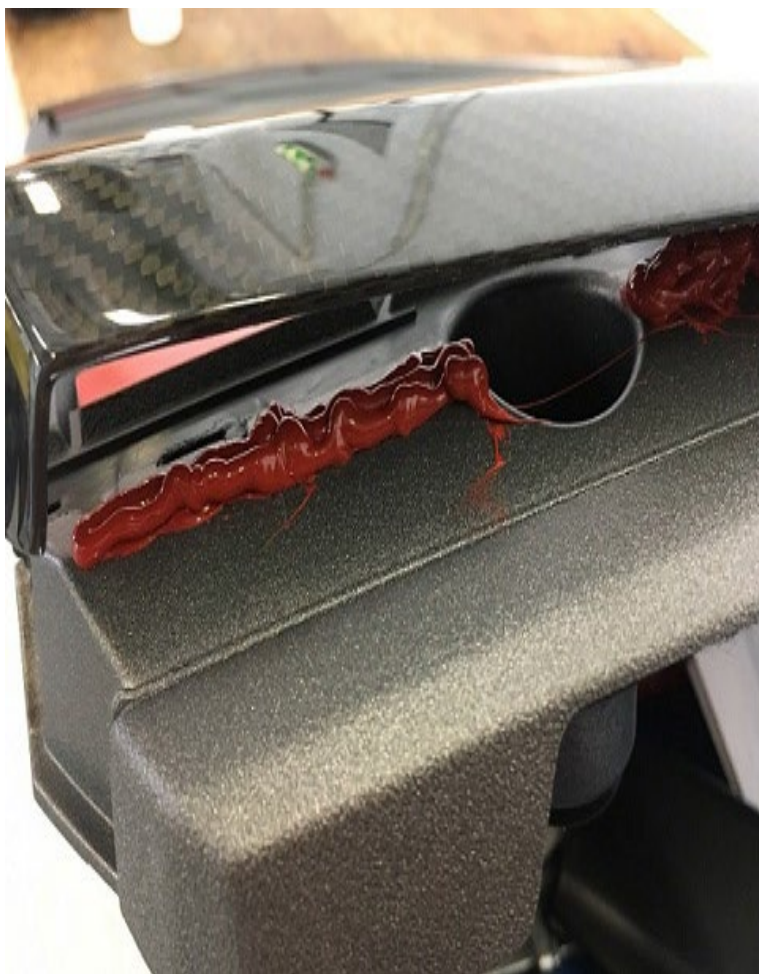
Figure 5. Applying adhesive.

Figure 6. Applying adhesive.

3. Apply the adhesive generously on the middle edge of the two surfaces below the trim panel (Figure 5 – 6).

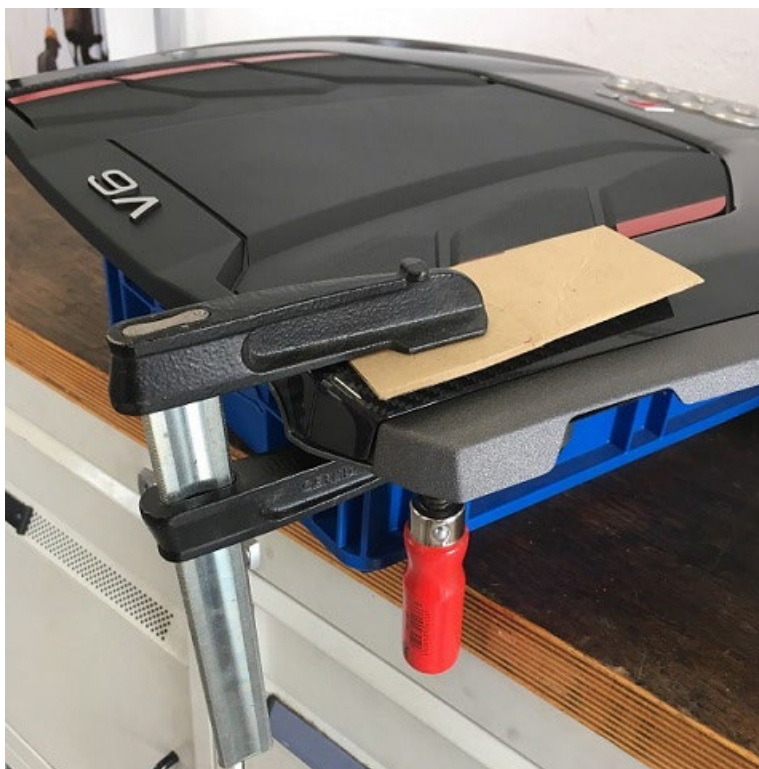
Figure 7. Put the cover in position and clamp together.

4. Put the trim panel and the engine compartment cover in position with a screw clamp and let the adhesive harden for 4 hours (Figure 7).
